The Hugh Mercer Apothecary

*Fredericksburg, Virginia
Historic Structures Report, Part A
Fall 2014*

By Mary Fesak
University of Mary Washington Student

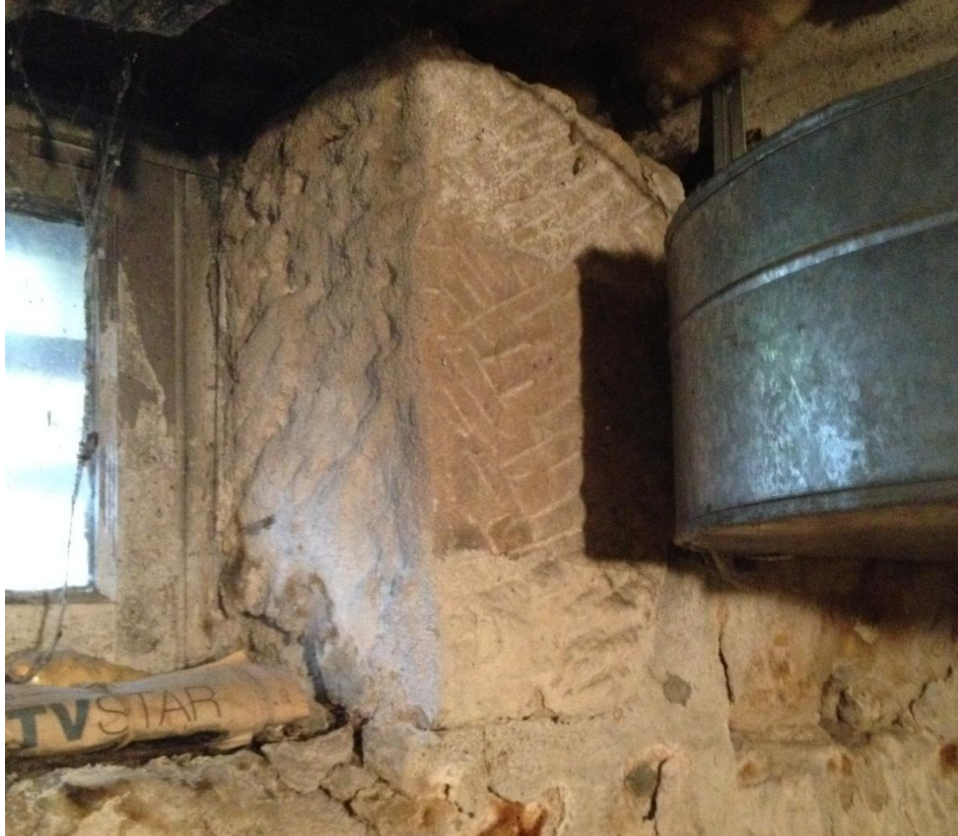
Figure 4 shows the scabbed Aquia sandstone.

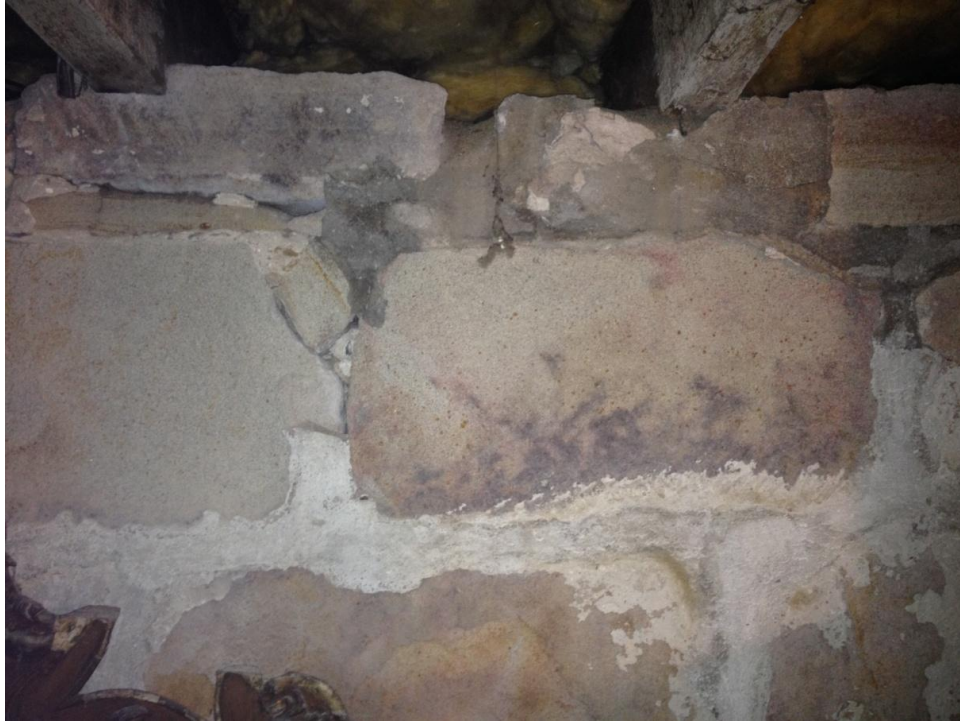
Figure 6 shows Portland mortar repairs.

Conversely, the exterior brick on the south wall is in good condition, although there has been some mortar loss. Improper mortar repairs using smear techniques, where the mortar feathers over the edges of the brick, and hard Portland mortars which leach sulfate impurities that can make adjacent historic mortars lose their adhesion, combined with exposure to weather have caused the weaker mortars to deteriorate.⁹⁰ The improper mortar repairs also have the potential to damage the brick since they impede the brick's ability to expand and contract when changes in temperature and humidity occur or during freeze-thaw cycles when the brick is water saturated and experiences internal pressures similar to cryptoflorescence, except from the formation of ice instead.⁹¹

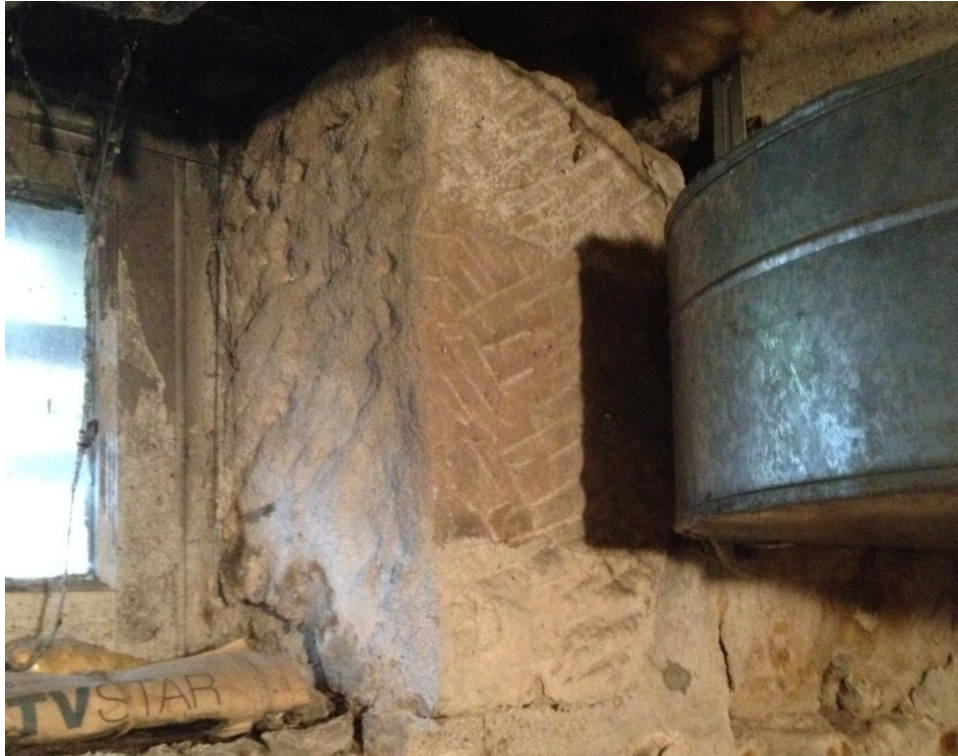
Figure 7 shows the scabbed Aquia sandstone.

The surface of the sandstone has failed in multiple locations on the interior, as well as the exterior of the east foundation wall. The exterior of the east foundation has experienced considerably more degradation than the other exterior foundations because the foundation plantings and mulch slow the evaporation of water, causing moisture to remain near the foundation for extended periods of time. The most extensive damage may have been caused in the past when there appears to have been a downspout from the gutters attached to the east wall beneath the middle dormer. The downspout may have leaked, causing water to collect along the foundation.⁸⁷ On both the interior and exterior, improper repointing with Portland mortars, which prevent the stone from expanding in moist conditions, combined with the cycles of hydration and dehydration of water-soluble salts result in the formation of cryptoflorescence, or the efflorescence of salt crystals inside the sandstone's pores. The formation of salt crystals creates internal pressures within the sandstone, which can lead to the failure of the stone's surface when the relative humidity regularly fluctuates around 75%. The salts go in and out of solution at 75% relative humidity; the resultant pressures created by the repeated efflorescing cause the crumbling of the stone's surface over time.⁸⁸ These conditions exist in the basement as the relative humidity fluctuated around 75% approximately five times during October. In the north room, the stone deterioration has been compounded by the Portland cement floor and moisture-imperious paint which forces water up the walls through capillary action, or rising damp. Since the sandstone has high porosity, the water containing soluble salts has risen approximately two-to-three feet above the floor, causing the surface of the affected stone to fail.⁸⁹

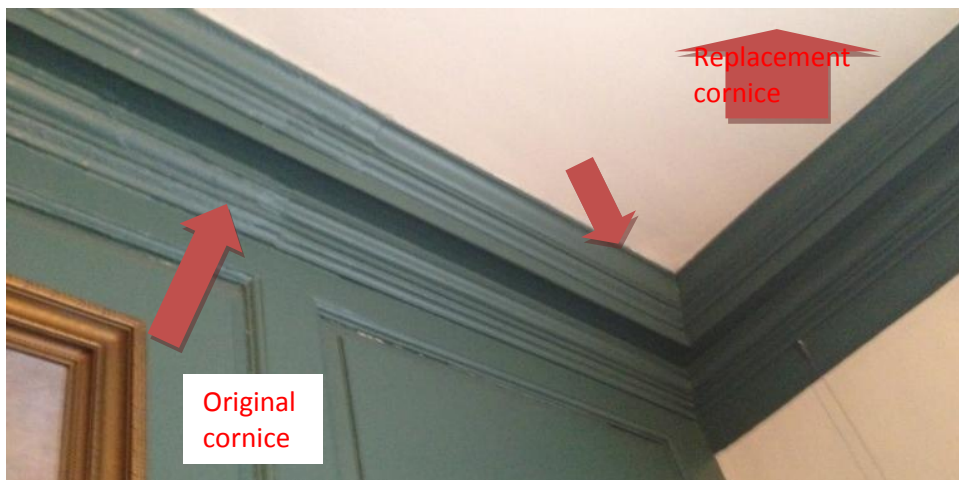
Figure 21 shows a section of cornice that has been replaced. The original cornice has muted edges from numerous layers of paint, while the replacement cornice has sharper edges.

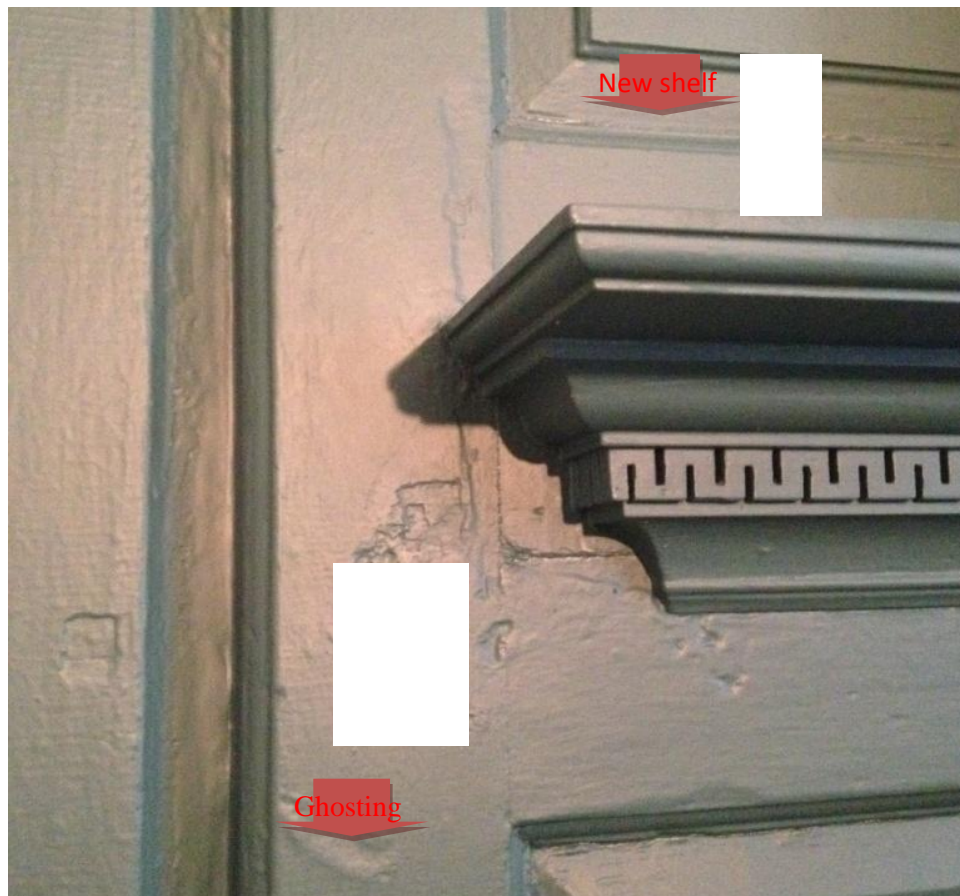
Figure 23 shows ghosting where features have been removed from the mantelpiece. The fretwork shelf is a newer feature that does not date to the building's period of significance.

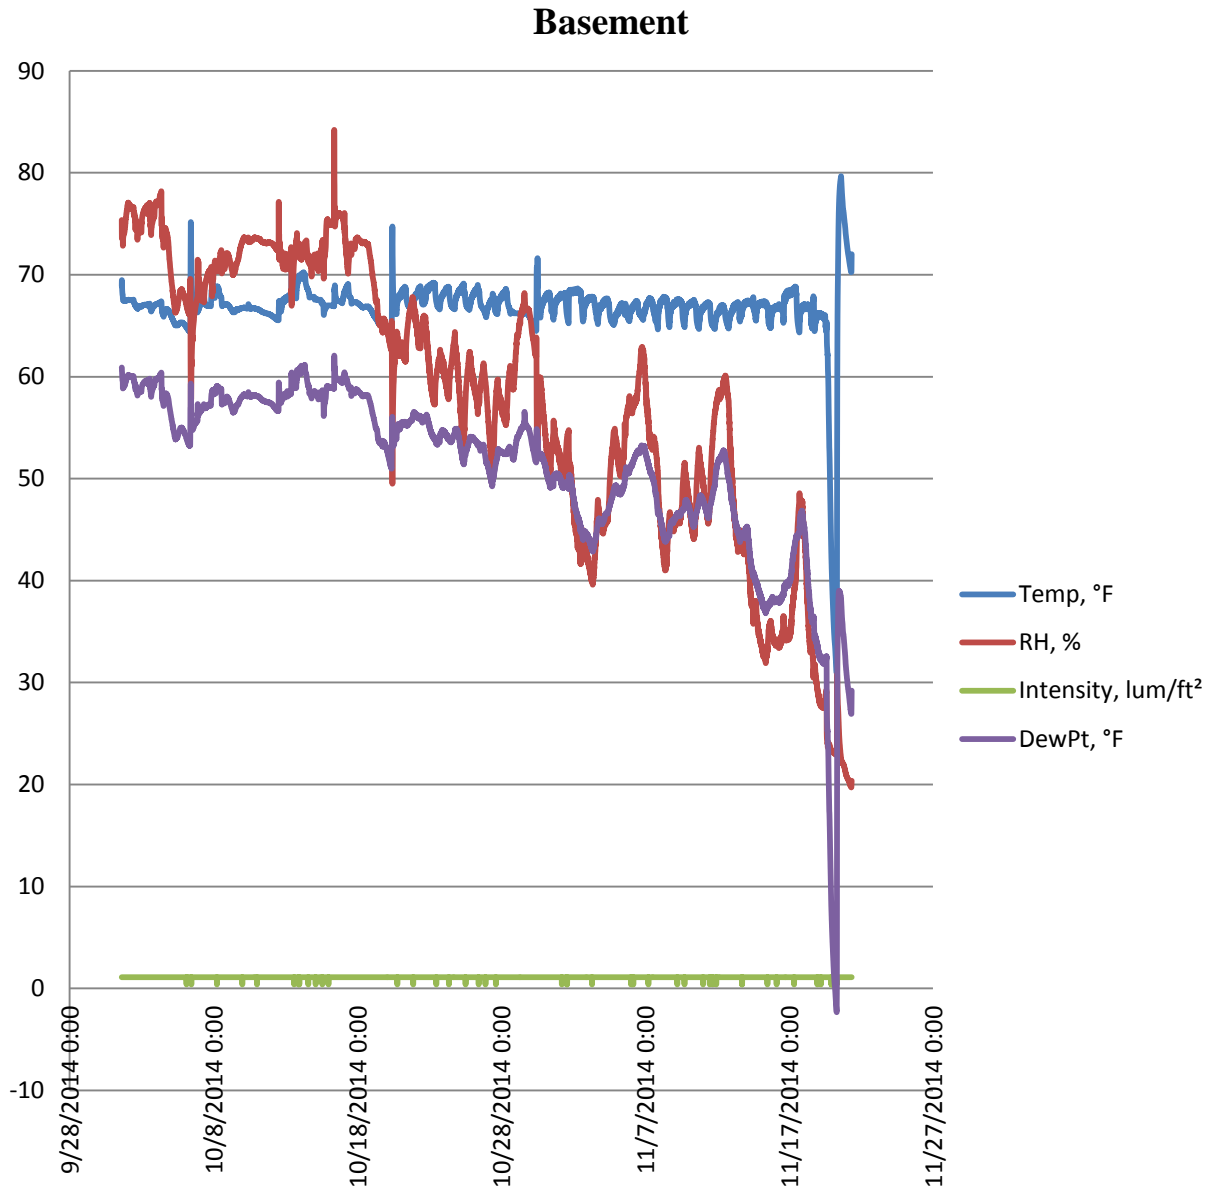
Figure 25 shows the data logger results for the basement.

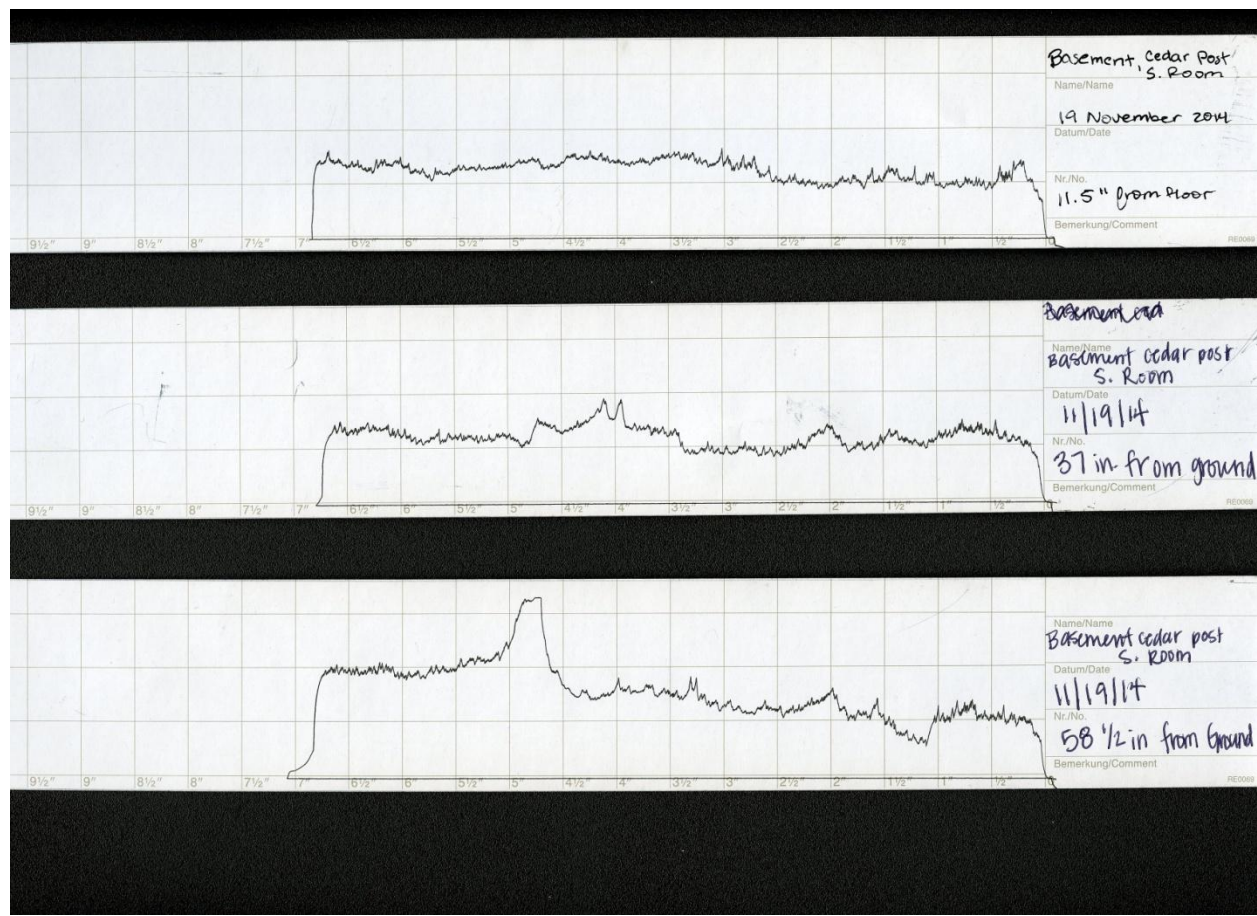
The resistance drill tests for the post in the south room show that the wood is not deteriorated.

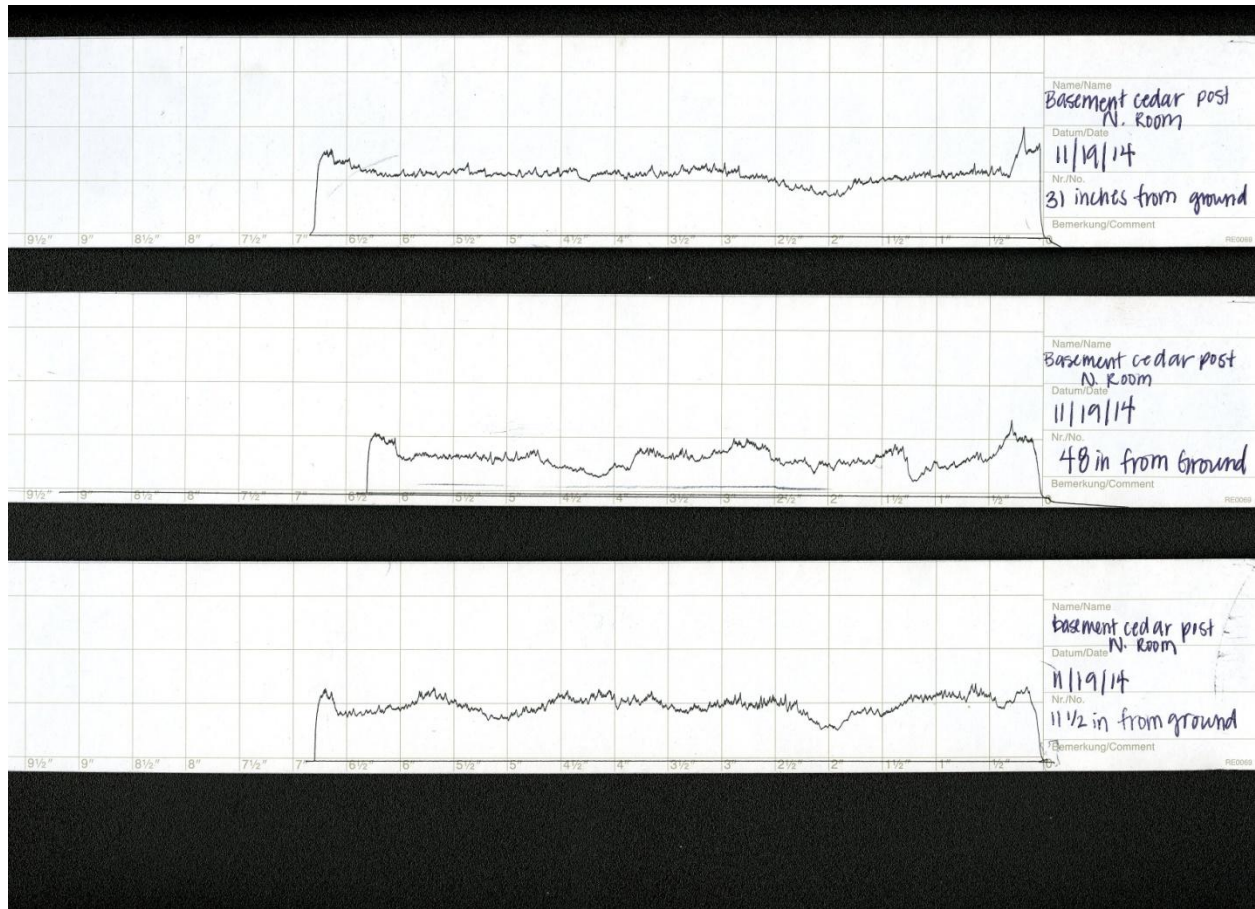
Similarly, the post in the north room is also not deteriorating.

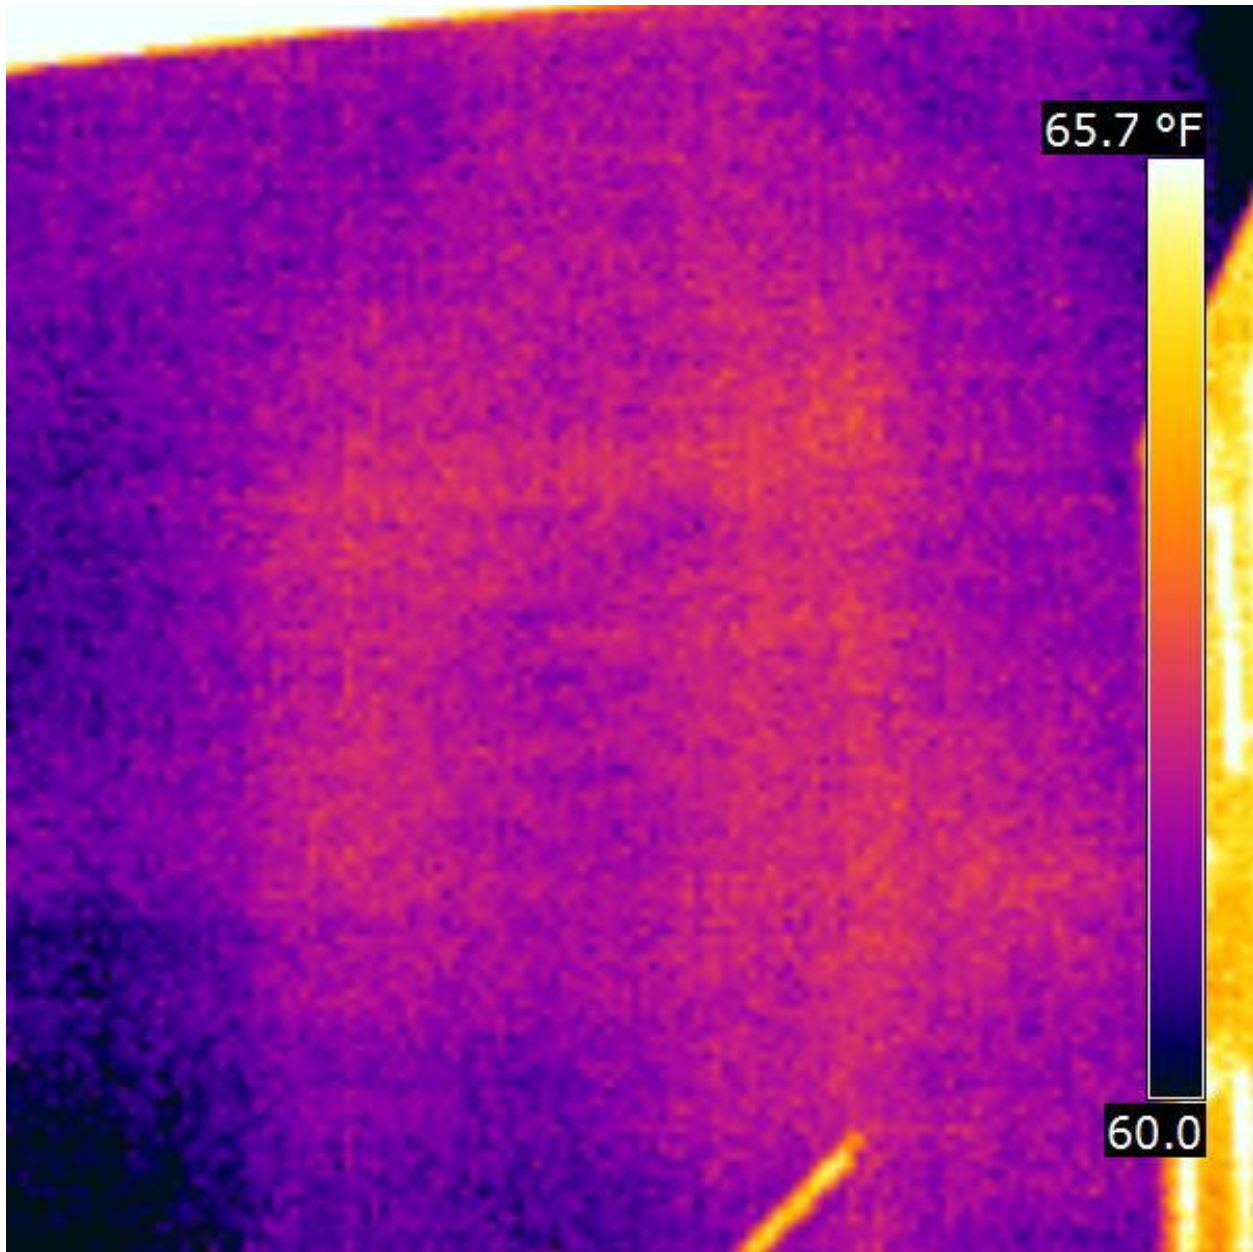
This infrared image shows of the south wall the location of the original entrance to the dwelling. Infrared images of the building showed that there were no areas of moisture damage or rot.
