St. Mary's Interior Paint Report

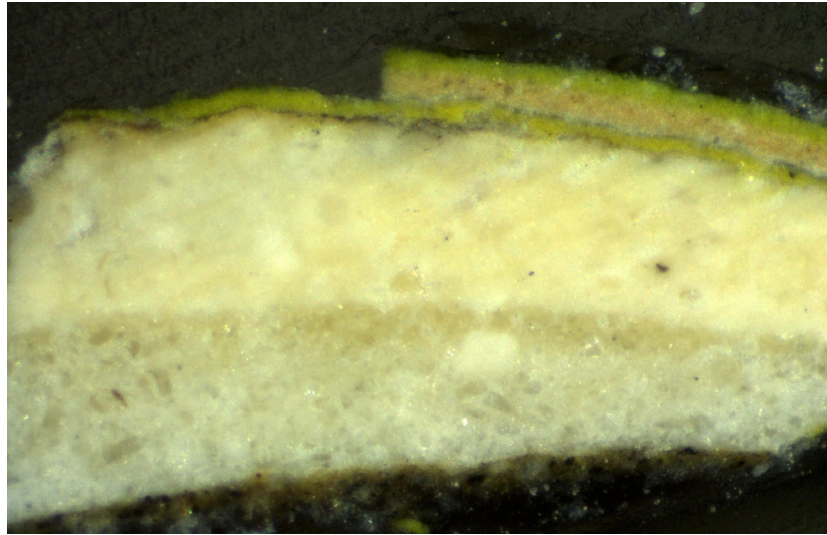
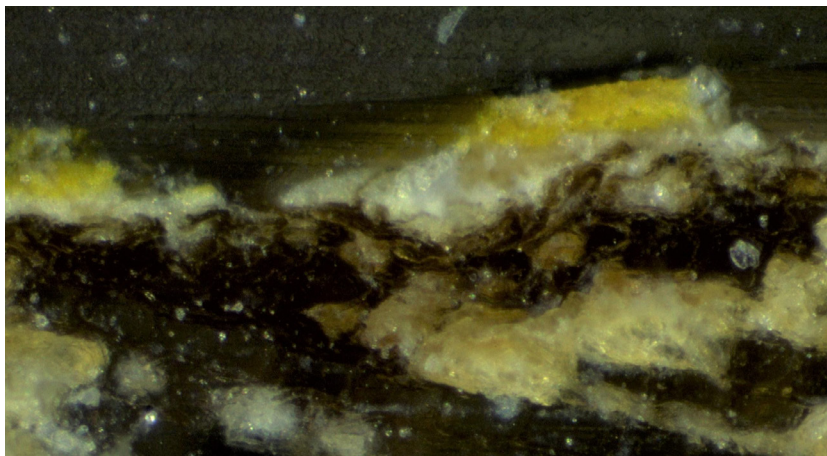
Sample one was taken from the top of the column shaft. There are approximately seven layers of paint with a wood substrate. The substrate is abraided and filled with a white substance, indicating that the column may have been sanded. The earliest campaign appears to have been a faux wood grain with a light grain color, dark graining color and a clear coat of varnish. The column was painted different shades of beige, cream, and white in more recent years.

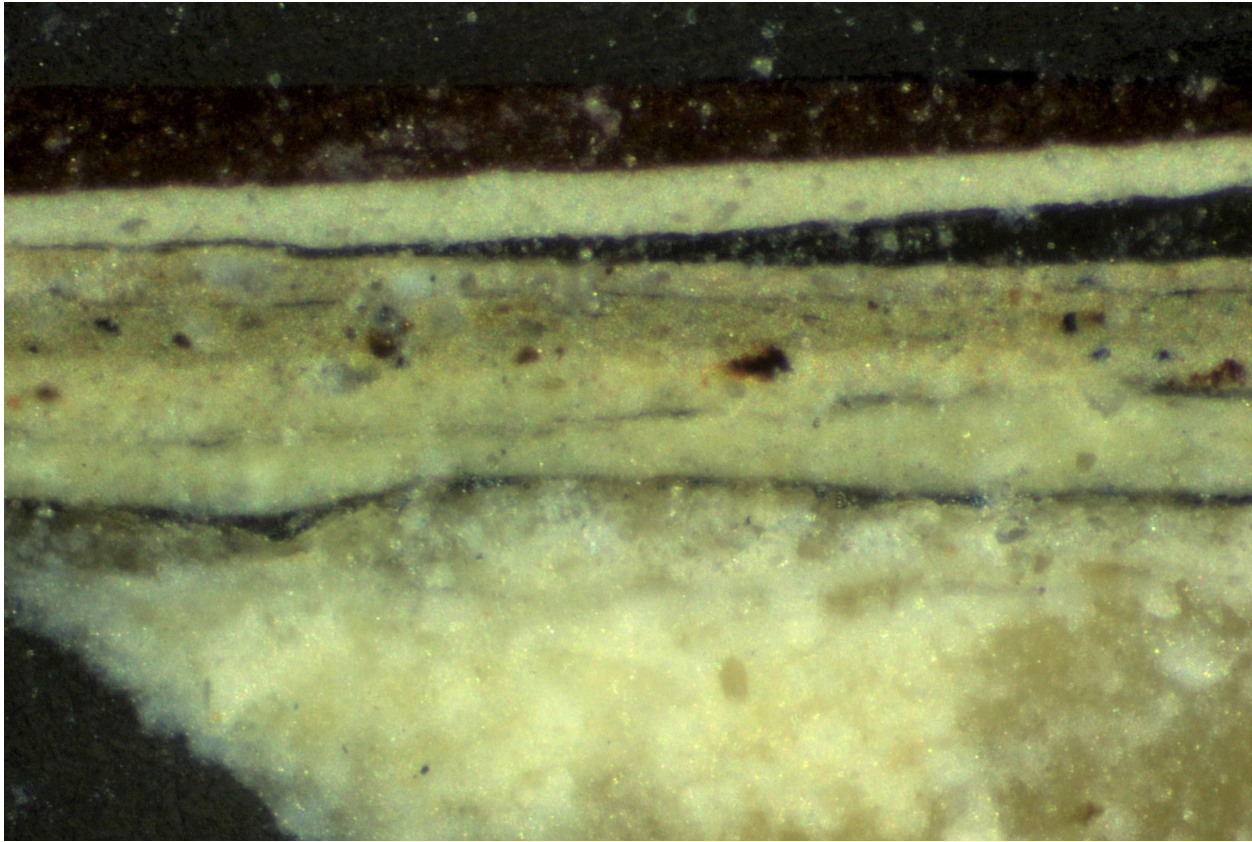
Sample two was taken from the column capital just above the volute. There are approximately seven layers of size and gilding with a wood substrate. The substrate is abraided and filled with a white substance, indicating that the capital may have been sanded. The capital appears to have been gilded three different times. Size was applied prior to the gold leaf to help it adhere. The most recent size was a shellac, which effloresces orange under ultraviolet light.

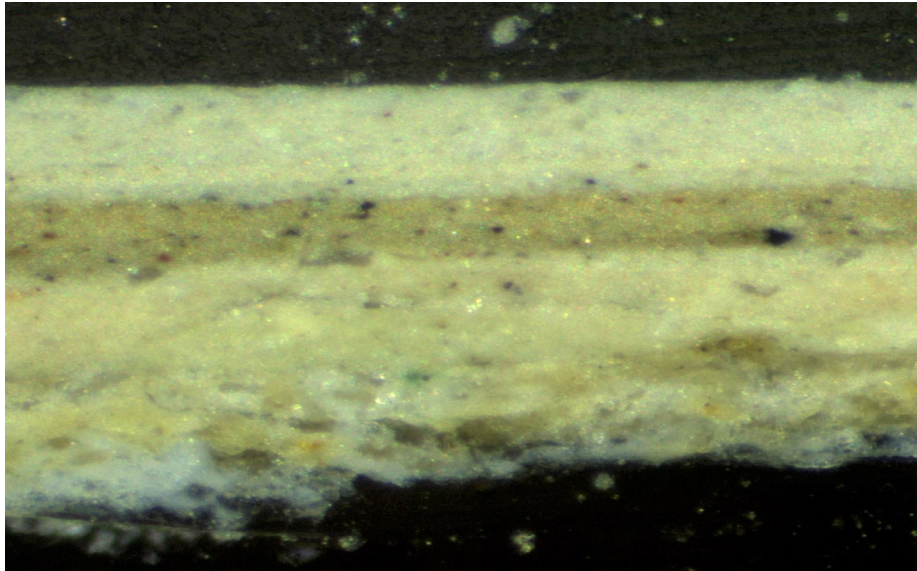
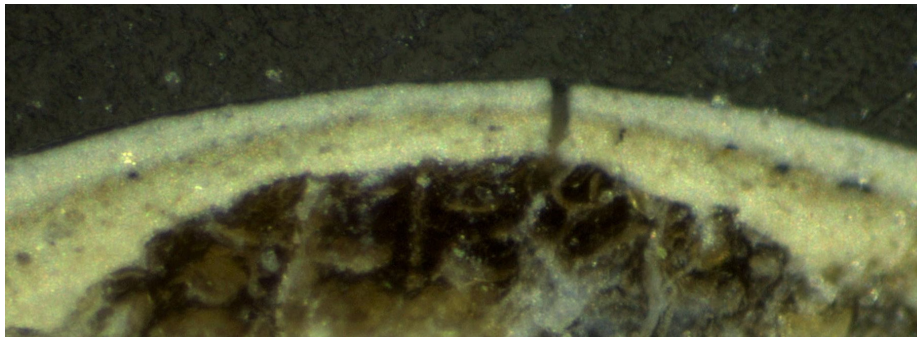
Sample three was taken from near a crack in the base of the column. The substrate appears to be material used in the past to fill the crack. There are approximately six layers of paint. The earliest color is a cream. There were several later campaigns of cream and beige paints. The base of the column has only recently been painted brown. Additional samples or exposures should be conducted to see if the base was faux grained like the column shaft.

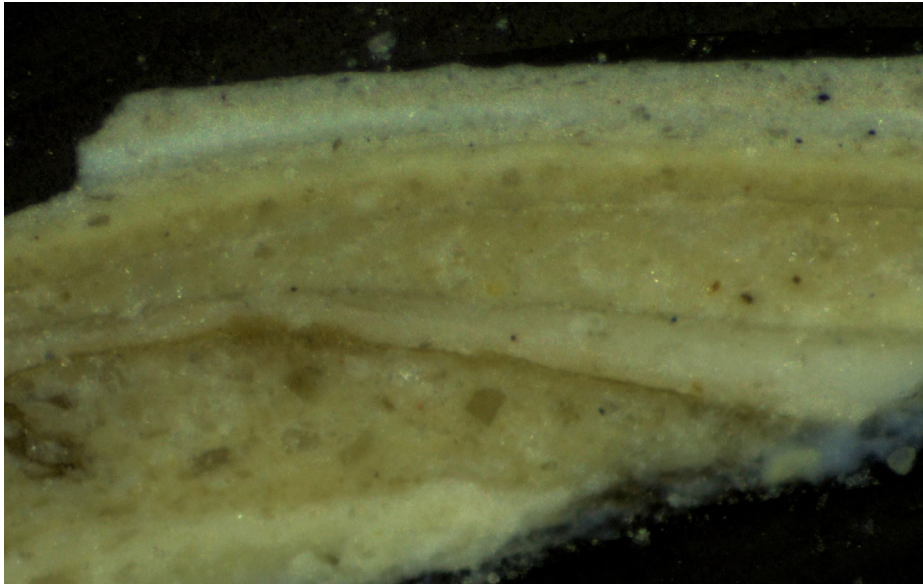
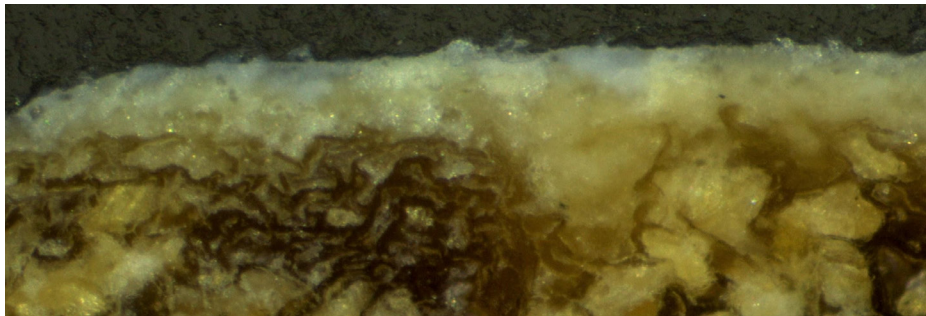
Sample four was taken from the molding in the door surrounds of the left door when exiting the sanctuary. There are approximately six layers of paint with a wood substrate. The substrate is abraided and filled with a white substance, indicating that the door surrounds may have been sanded. The earliest campaign appears to be a beige color with subsequent campaigns of beige and cream paints.

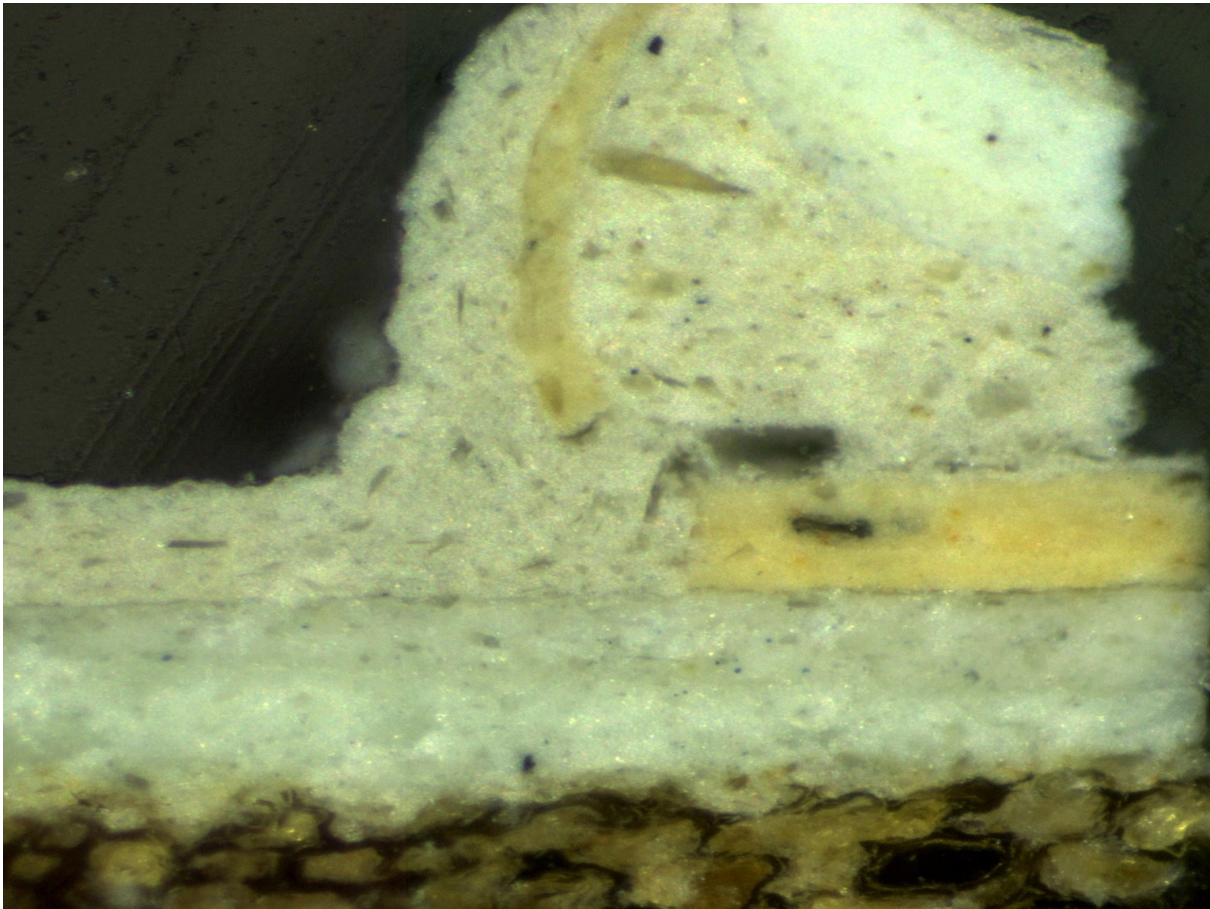
Sample six was taken from the molding above the left door when exiting the sanctuary. There are approximately seven layers of paint with a wood substrate. The substrate is abraided and filled with a white substance, indicating that the molding may have been sanded. The earliest extant paint layer was cream with subsequent layers of beige, yellow, and cream.

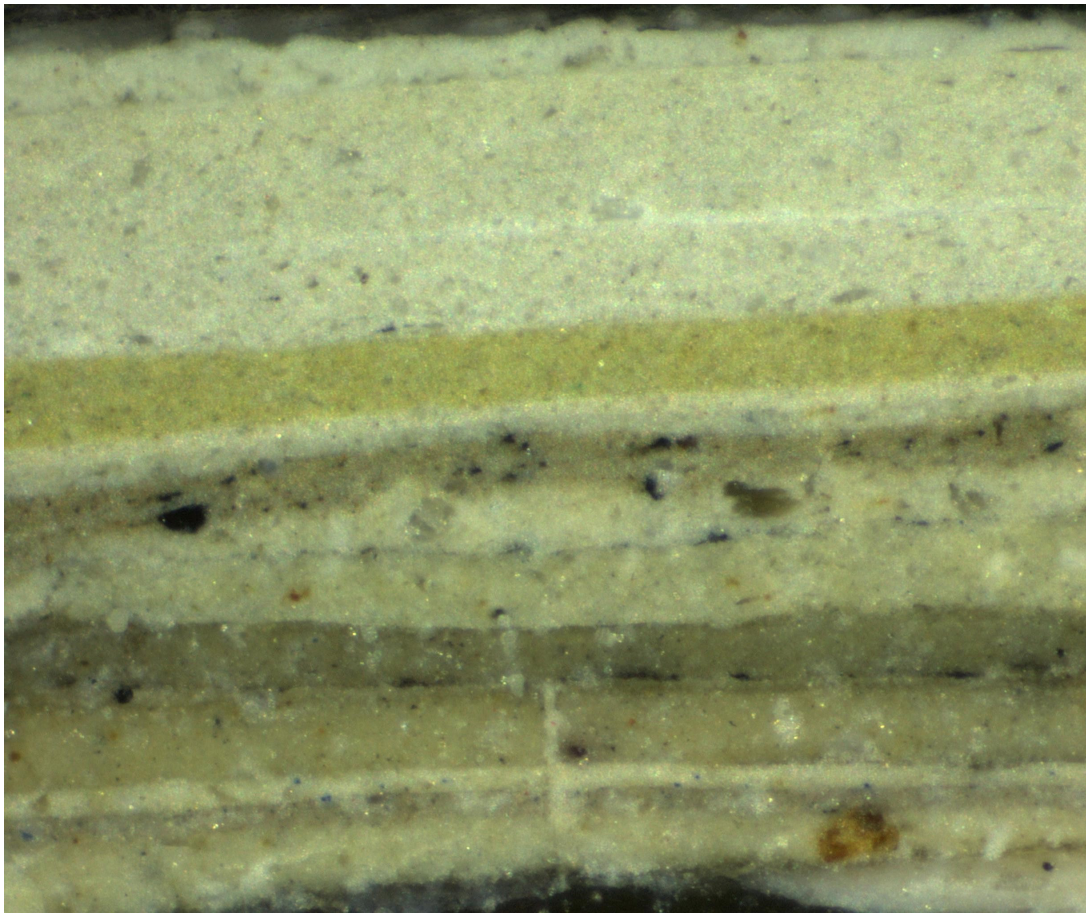
Sample seven was taken from the beadboard ceiling above the left door when exiting the sanctuary. The wood substrate has a rough texture, indicating that it may have been sanded. There are approximately five layers of paint. The earliest color is a white. The third layer of yellow appears to have been scraped or peeled back before the current cream layer was applied. There is also a piece of a white layer encapsulated in the current cream layer. It is unclear from the sample where the white layer came from.

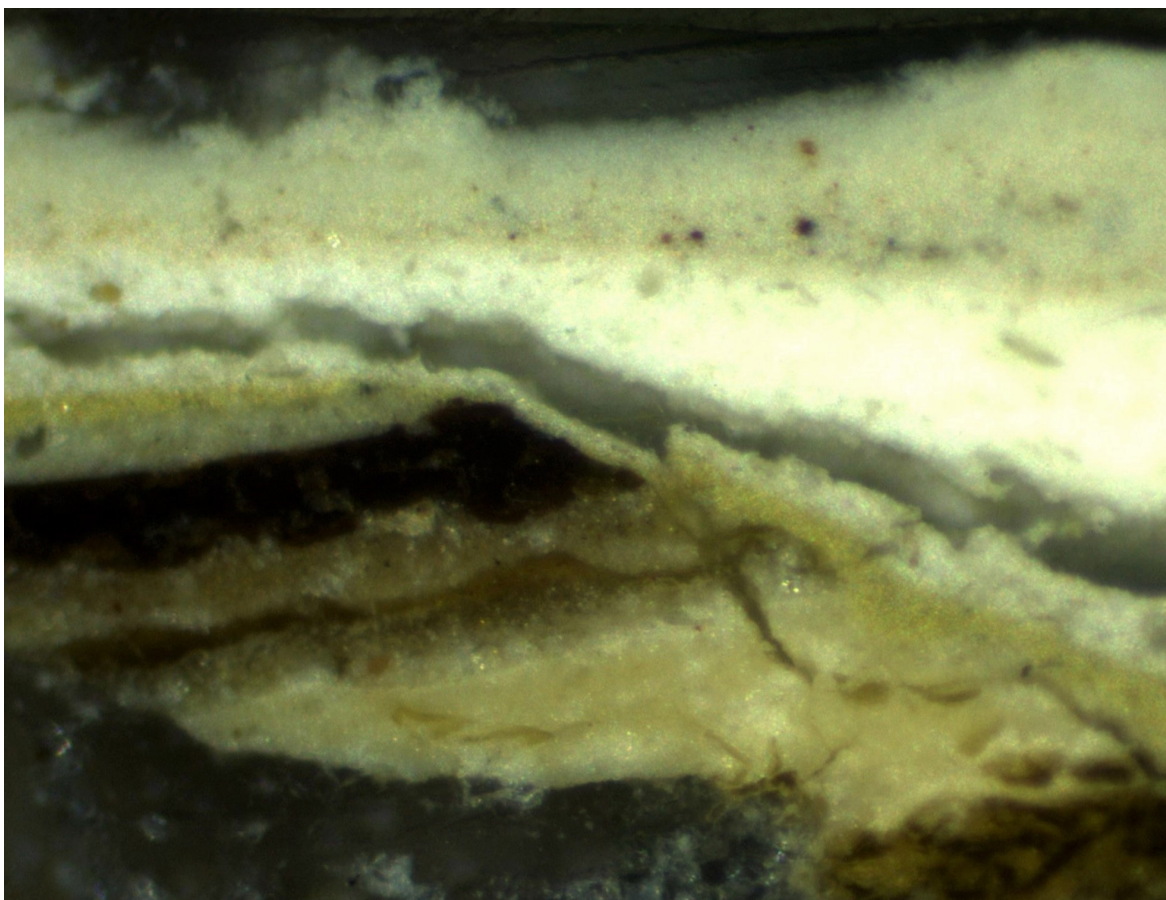
Sample eight was taken from the door surrounds to the left of the right vestibule side door. The wood substrate is missing. Off-white appears to be the earliest paint color out of approximately thirteen paint campaigns of mostly beiges and creams.

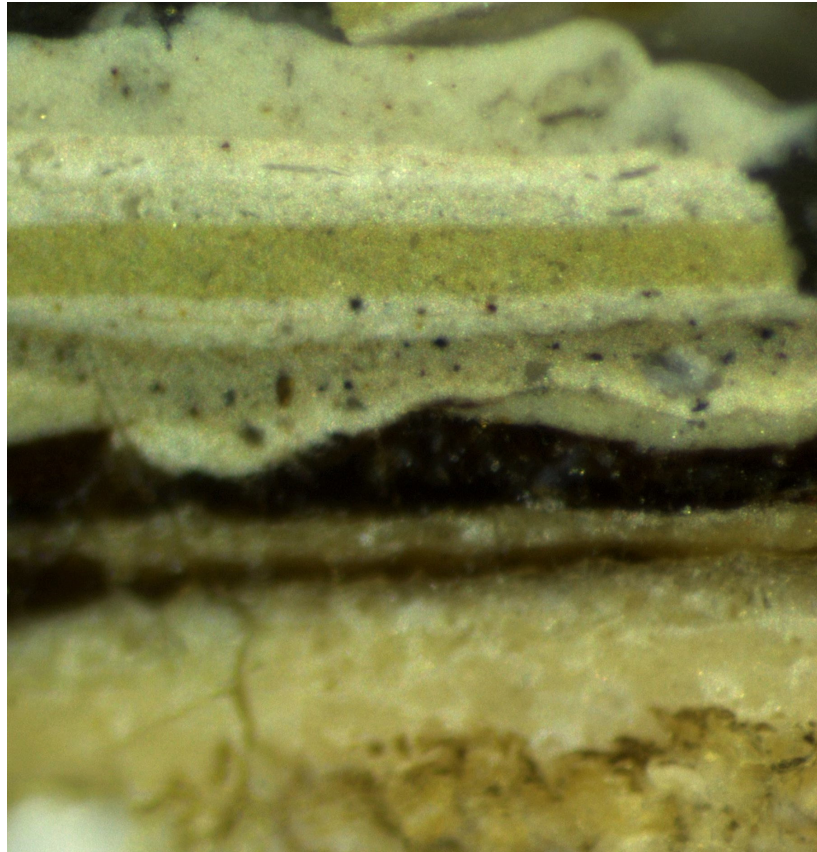
Sample nine was taken from the top of the left stile in the right vestibule side door. The wood substrate is abraided, indicating that it may have been sanded. The earliest campaigns appear to have been a faux wood graining with a cream layer of primer followed by several layers of brown, yellow, and white paints. There may have been multiple campaigns of faux graining because the paint layers also appear to have been abraided. The faux graining was sealed with a clear coat of varnish. More recently, the door has been painted in creams and beiges.

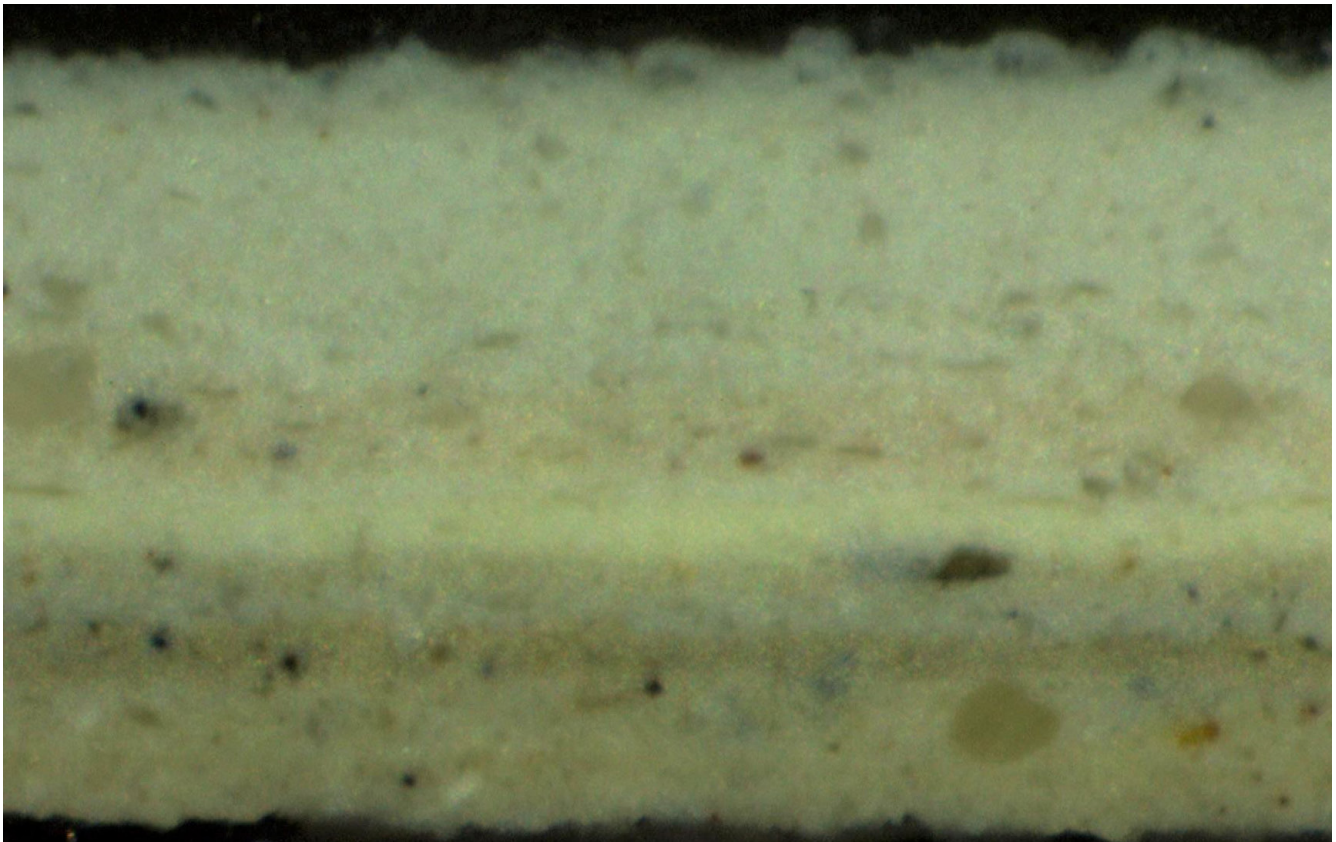
Sample ten was taken from the top left panel in the right vestibule side door. The wood substrate is abraided, indicating that it may have been sanded. The earliest campaigns appear to have been a faux wood graining with a cream layer of primer followed by several layers of brown paints. The faux graining was sealed with a clear coat of varnish. More recently, the door has been painted in creams, beiges, and yellow.

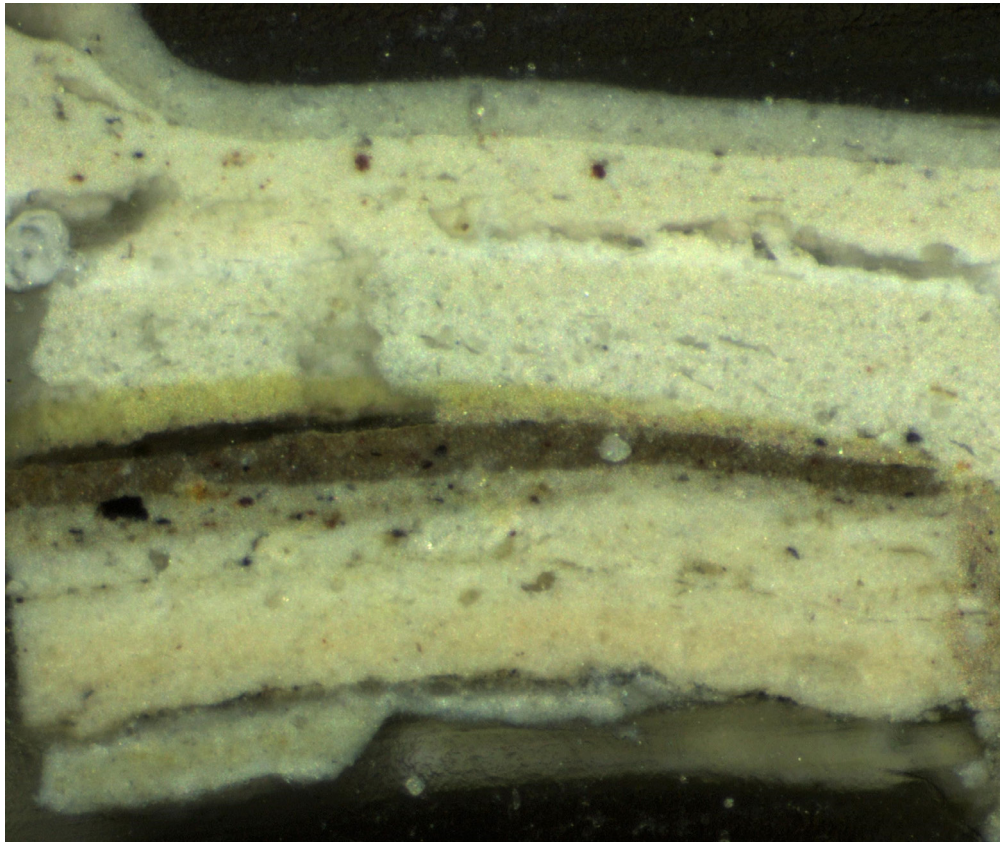
Sample eleven was taken from the edge of a hole in the right vestibule wall above the wall sconce. The bottom layer of the paint sample was taken from directly above the plaster substrate. The earliest campaign appears to have been a golden-beige with large inclusions, followed by later paint campaigns of yellows, peaches, creams, and beiges.

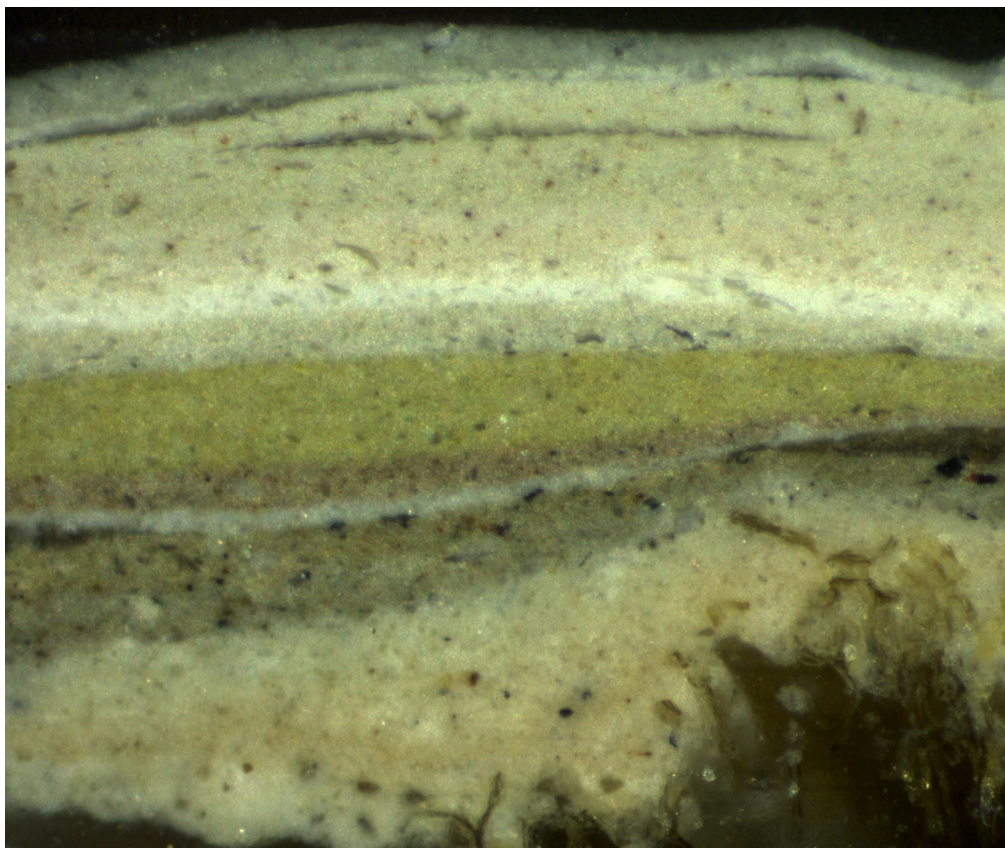
Sample twelve was taken from the baseboard on the right wall of the vestibule between the radiator and the corner. The substrate and perhaps the earliest color are missing. The earliest campaign appears to have been a beige similar to the current color. The vestibule baseboard was also painted different shades of creams, peach, yellow, and brown.

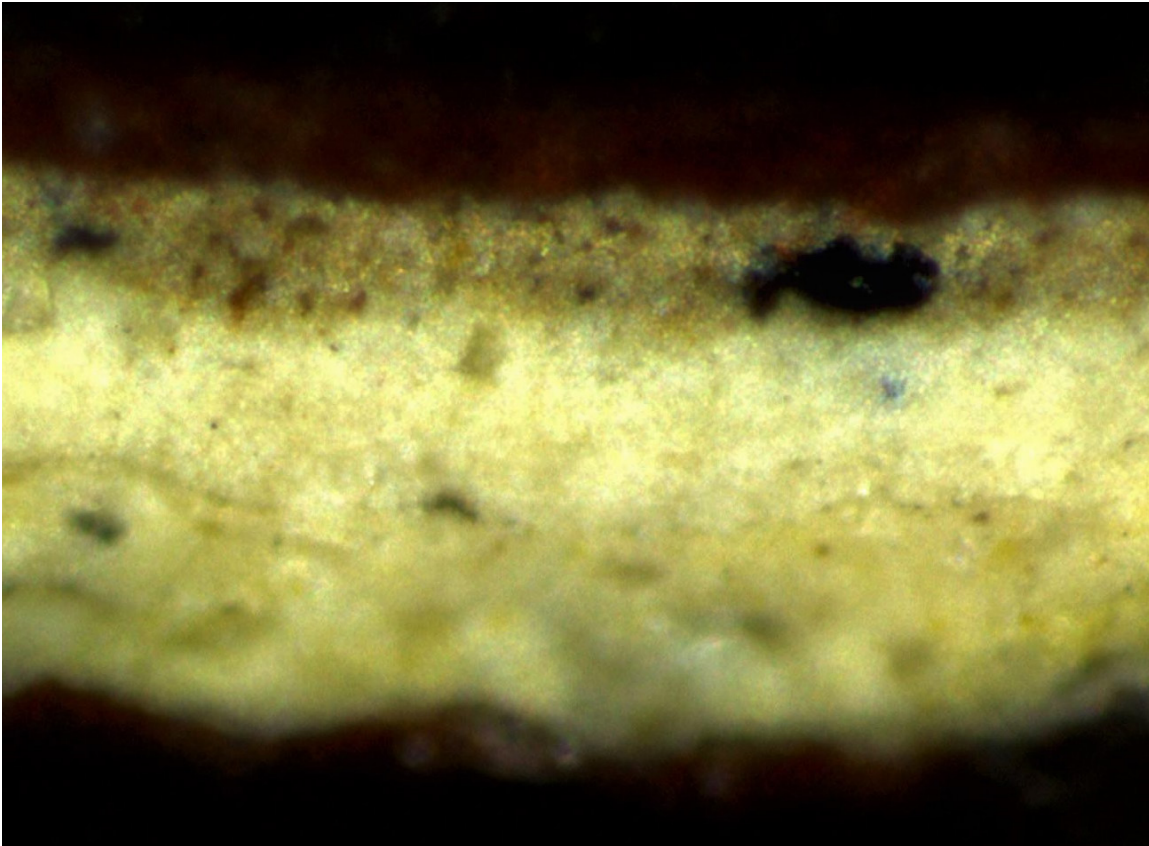
Sample thirteen was taken from the vestibule baseboard to the left of the right door into the sanctuary. The wood substrate is abraided, indicating that it may have been sanded. The earliest campaign appears to have been a cream. The vestibule baseboard was later painted different shades of creams, peach, yellow, and brown.

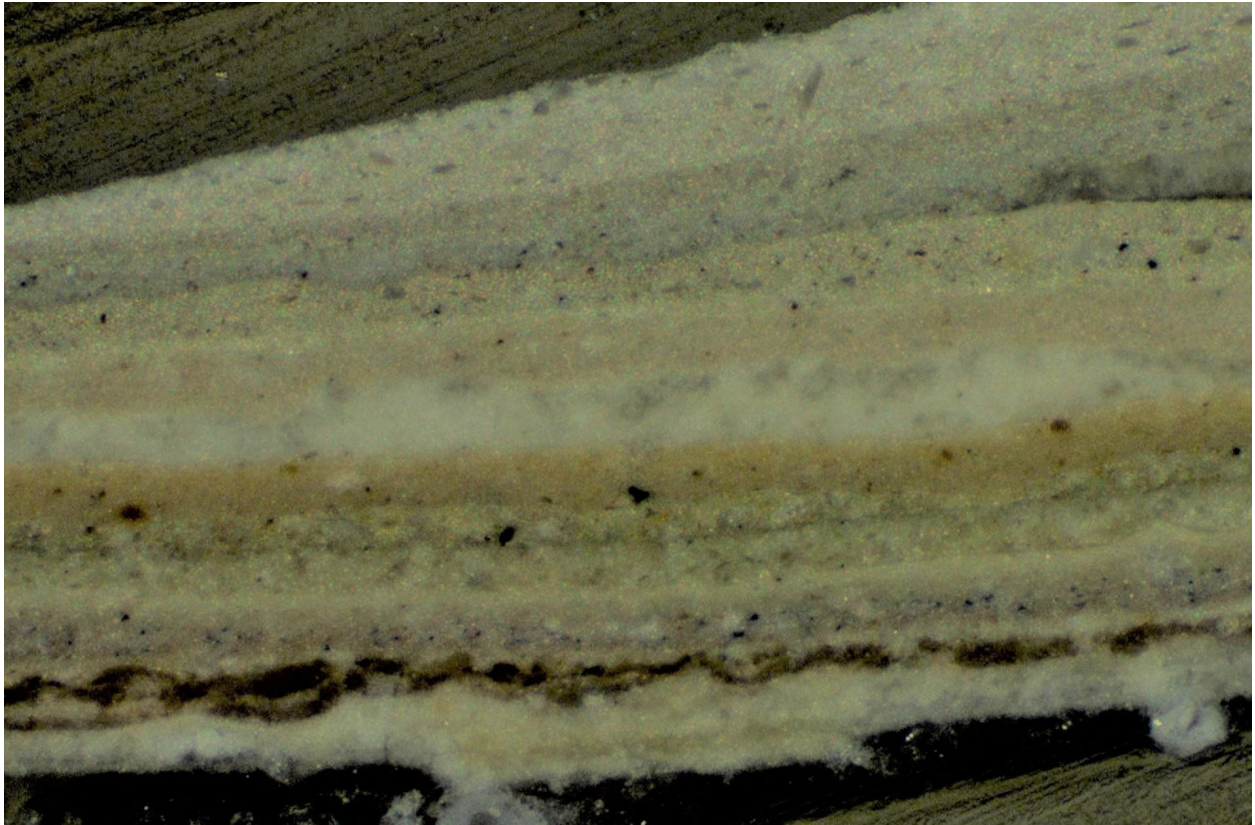
Sample fifteen was taken from the right side of the windowframe of the second window from the back on the left side of the church. The bottom layer of the paint sample was taken from directly above the wood substrate. Microscopic analysis of the substrate shows that it was abraided, indicated that it may have been sanded. The earliest layer of paint is a dark reddish-brown, similar to the current color. There were three campaigns of lighter-colored paint in between. Taken at 20x.

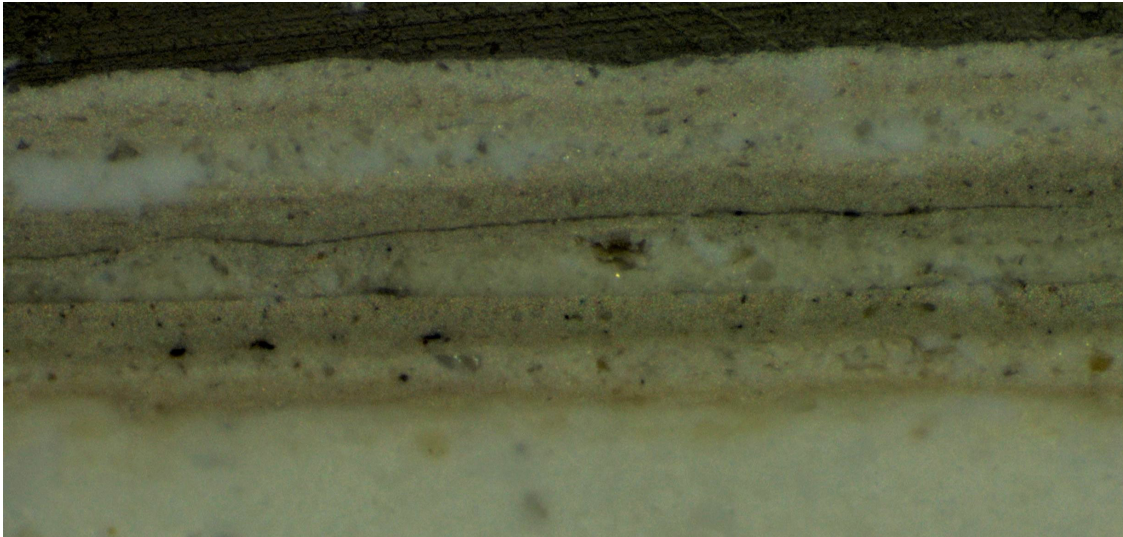
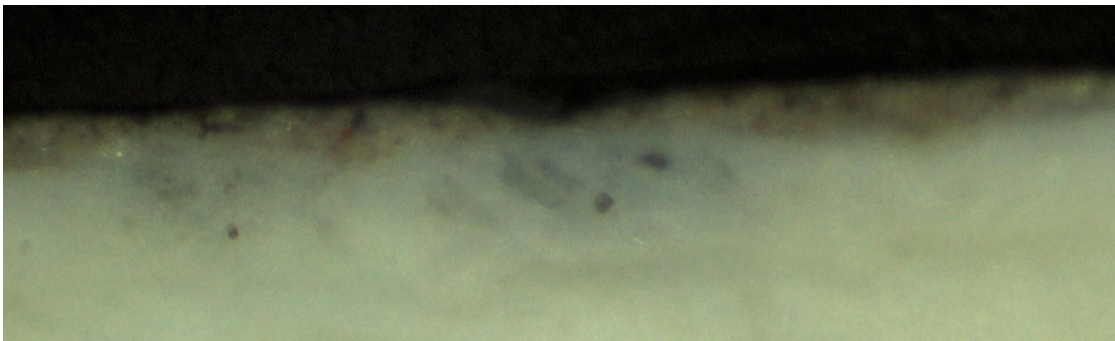
Sample seventeen was taken from the window alcove to the right of the second window from the back on the left side of the sanctuary. The plaster substrate is missing. The earliest campaign appears to have been a cream, followed by a dark brown, another cream, and a light blue. Peaches, yellows, creams, and beiges followed these early colors. Taken at 4x.

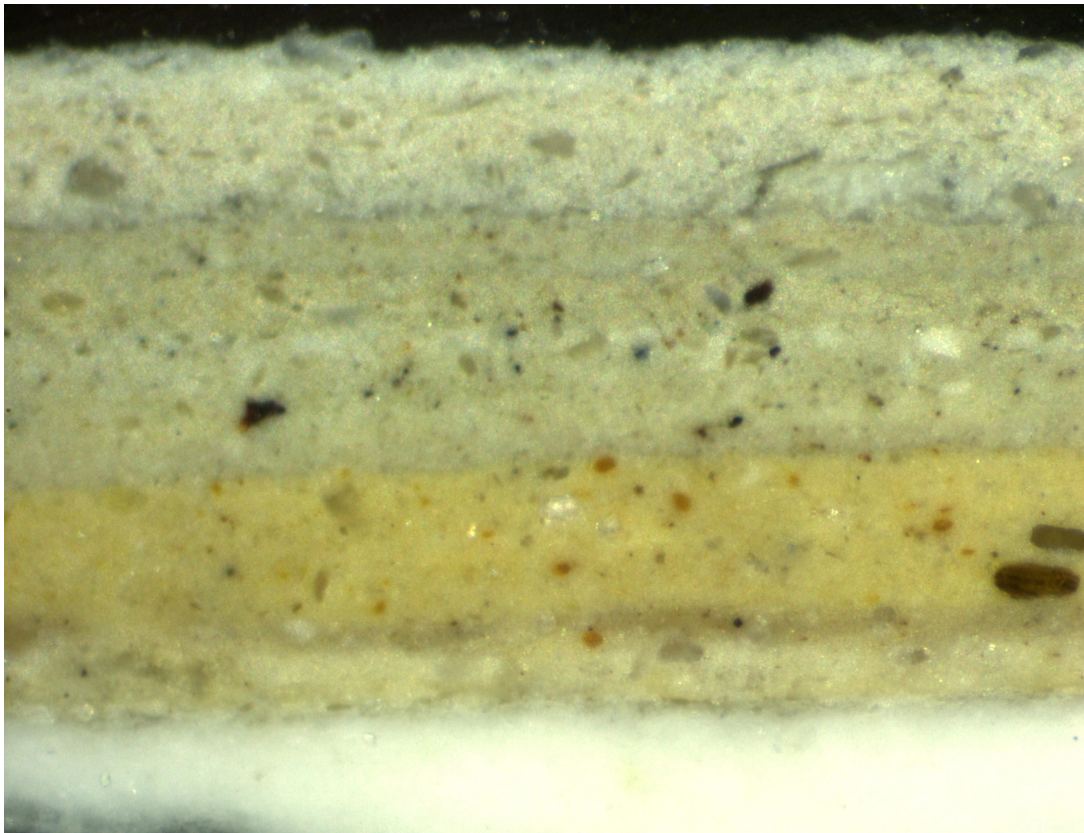
Sample eighteen was taken from the wall between the two windows towards the back of the right side of the sanctuary. There is one layer of reddish brown paint on the plaster substrate. It is likely the original wall color. A skim coat of plaster was applied over the reddish paint. The second paint color was likely a golden brown followed by cream and beige paint campaigns. Taken at 4x.

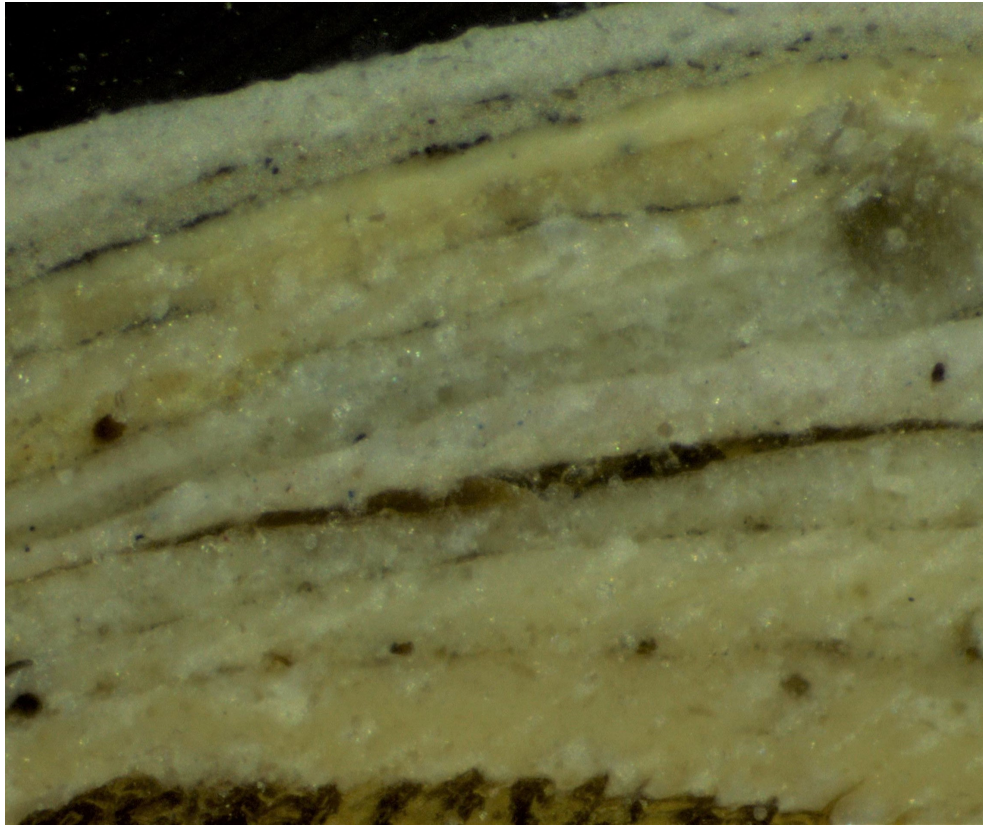
Sample twenty was taken from between the top and bottom first two windows on the right side of the sanctuary. The wall have been plastered and painted after the balcony was shortened. The first paint campaign is beige, indicating that the sanctuary walls were painted beige, then yellow after the balcony was shortened. Subsequent coats of beige paint have been less yellow in hue than the first coat.

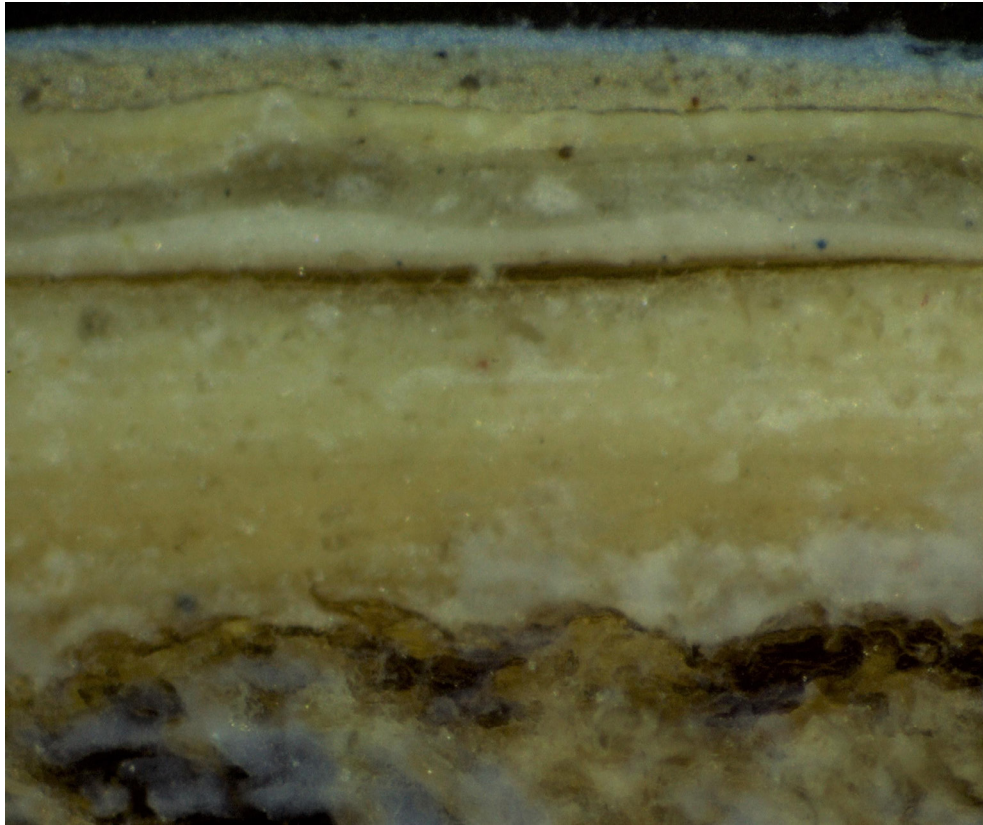
Sample twenty-one was taken from the beige molding along the bottom of the balcony on the right side of the sanctuary. The end of the balcony would theoretically have fewer layers of paint because it was shortened. The wood substrate is abraided, suggesting that it may have been sanded. The earliest color present was a cream. Subsequent paint campaigns have included creams, beiges, and brown.

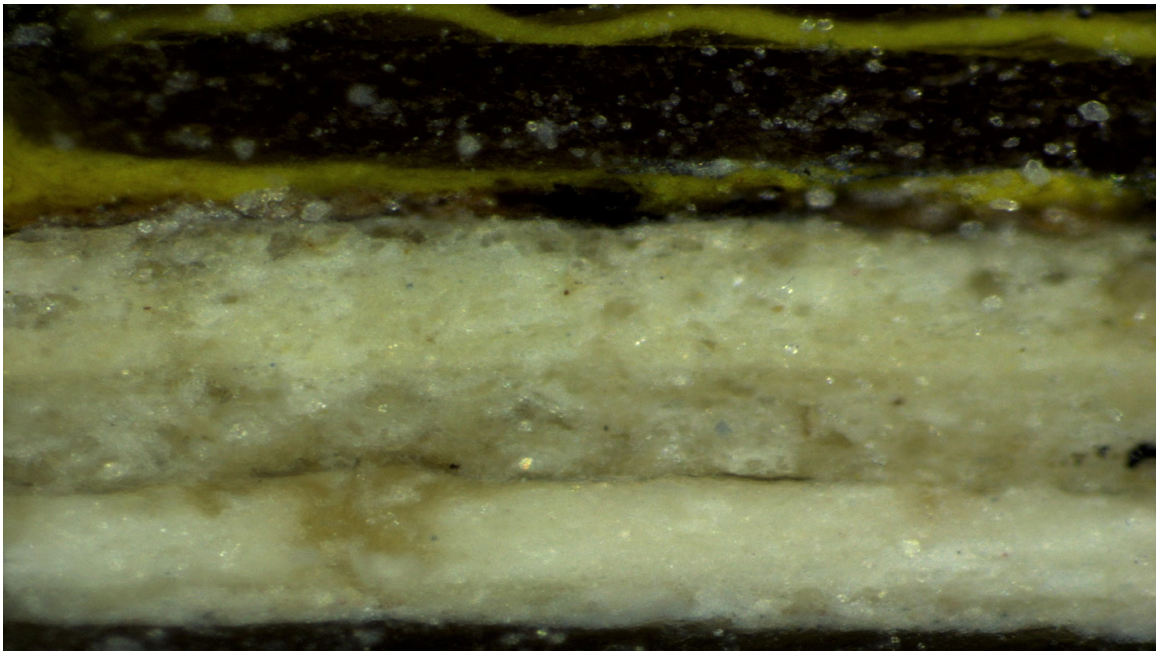
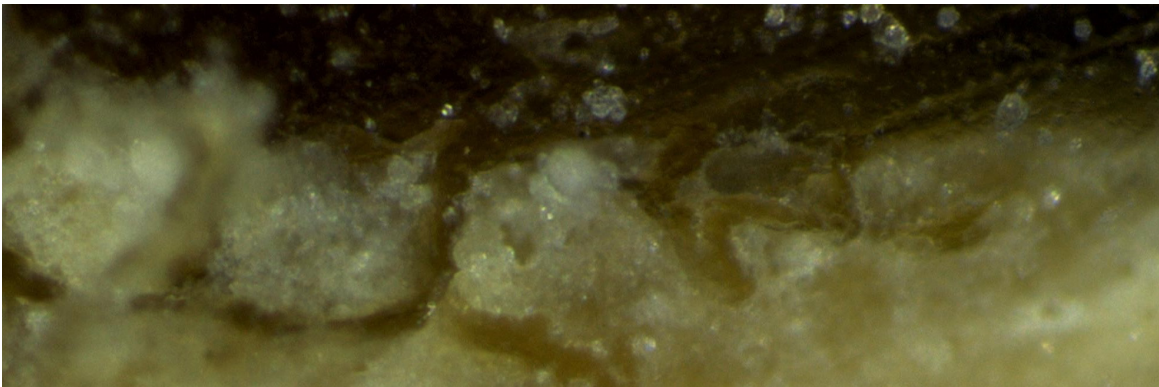
Sample twenty-two was taken from the blue band in the molding along the end of the balcony on the right side of the sanctuary. The end of the balcony would theoretically have fewer layers of paint because it was shortened. The wood substrate is abraided, suggesting that it may have been sanded. The earliest color present was a cream. Subsequent paint campaigns have included creams, beiges, and brown. It appears to have been painted the same color as the beige molding sampled in SMI_22 until it was painted blue. The current blue paint does not appear to have a precedent. Taken at 20x.

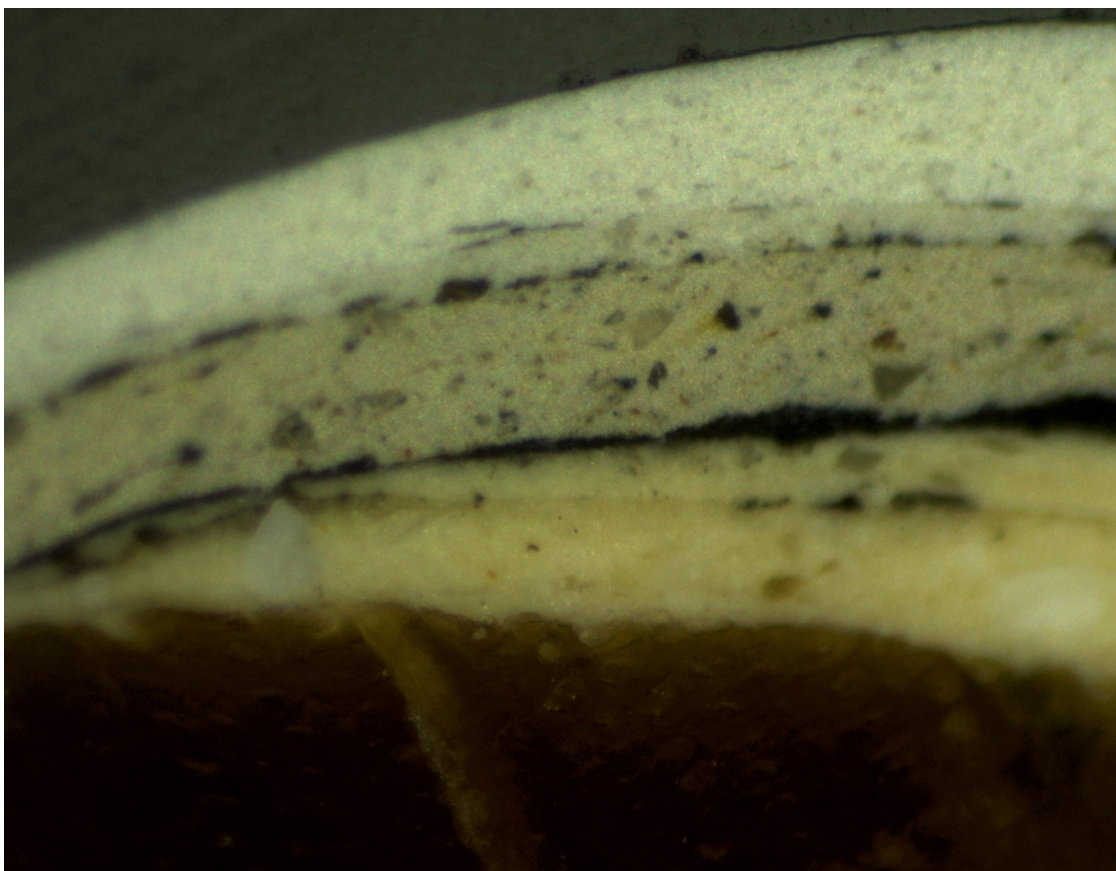
Sample twenty-three was taken from the gold beading along the end of the balcony on the right side of the balcony. The wood substrate is abraded like it was sanded. There appear to be gold flecks embedded in the wood cells, suggesting the beading may have originally been gilded. The intact layers appear to be cream with a varnish, followed by another layer of cream and two later campaigns of gilding. Taken at 20x.

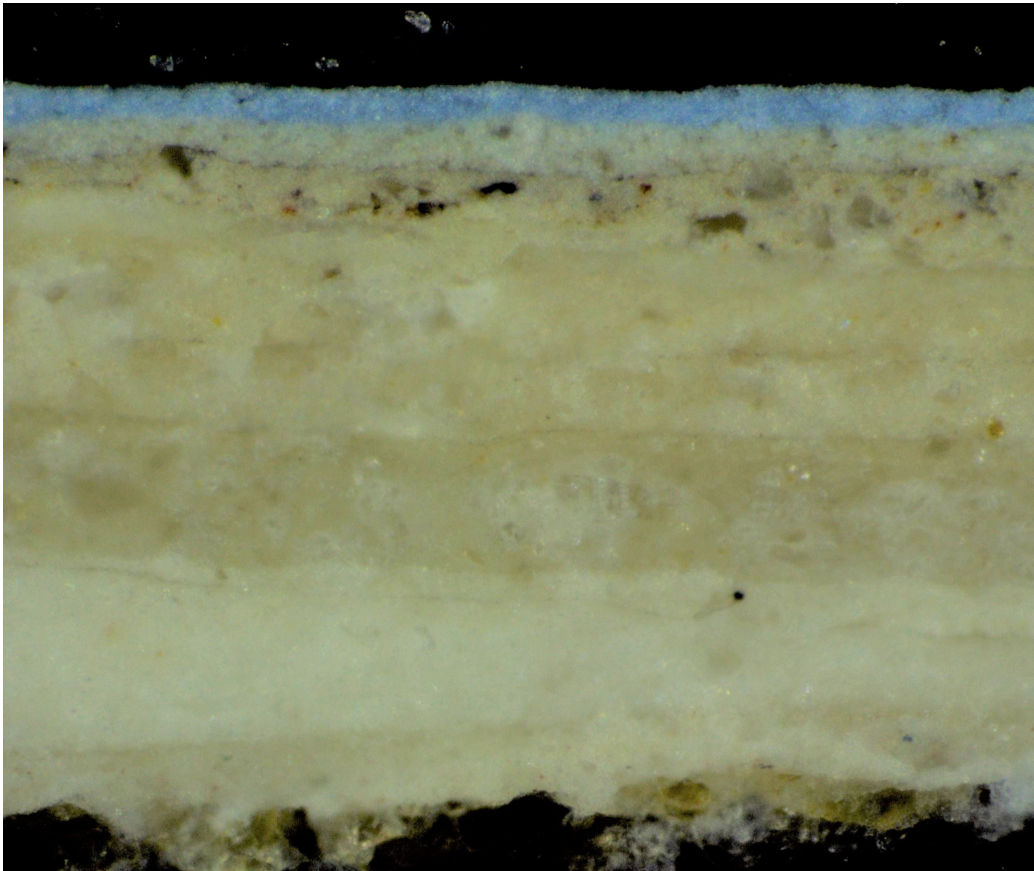
Sample twenty-four was taken from molding directly above the gold beading in the balcony directly below the organ. A sample from this location should have theoretically provided a sample of the original colors of the molding instead of the ends of the balcony, which were shortened. However, this sample has fewer layers than sample SMI_21. The earliest color is yellow, although the wood substrate appears abraded like it may have been sanded. It was painted yellow a second time before the molding appears to have been painted brown. The beige and cream colors are more recent.

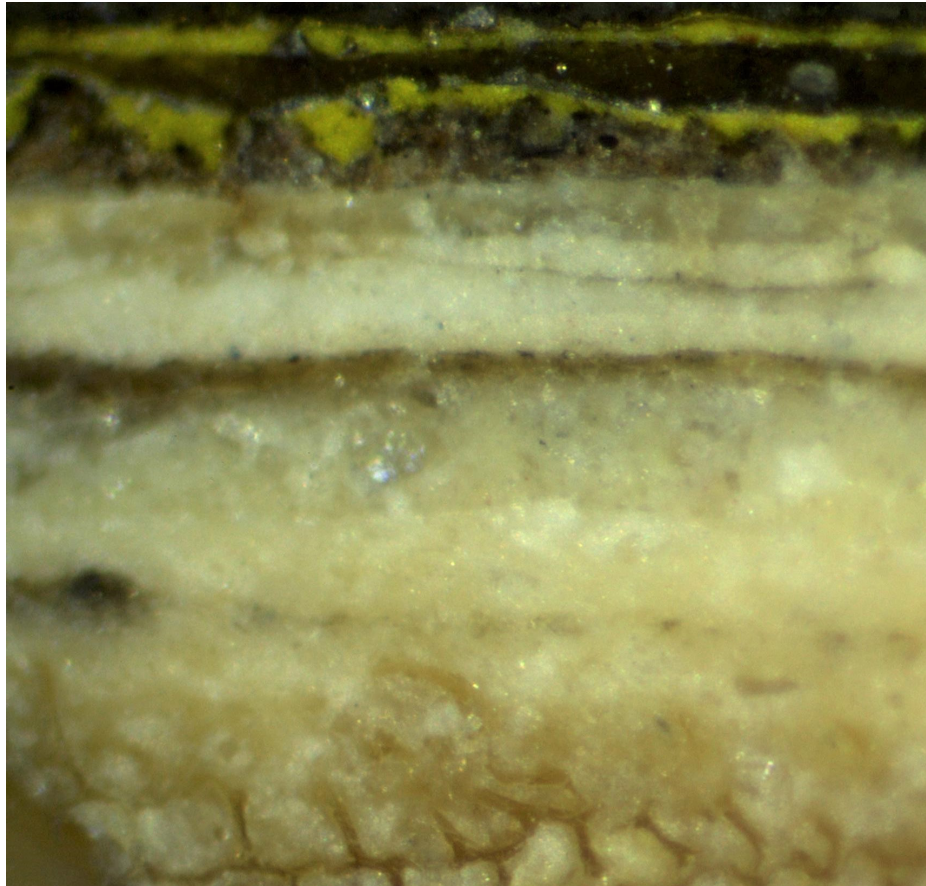
Sample twenty-five was taken from the blue band in the molding in the balcony directly below the organ. Since that part of the balcony is original, the sample could theoretically have more layers than SMI_22, but it does not. It has the same number of layers, but some of the colors are different. The wood substrate is abraided, suggesting that it may have been sanded. The band presently painted blue appears to have been painted cream for most of its existence. Taken at 20x.
