St. Mary's Interior Paint Report

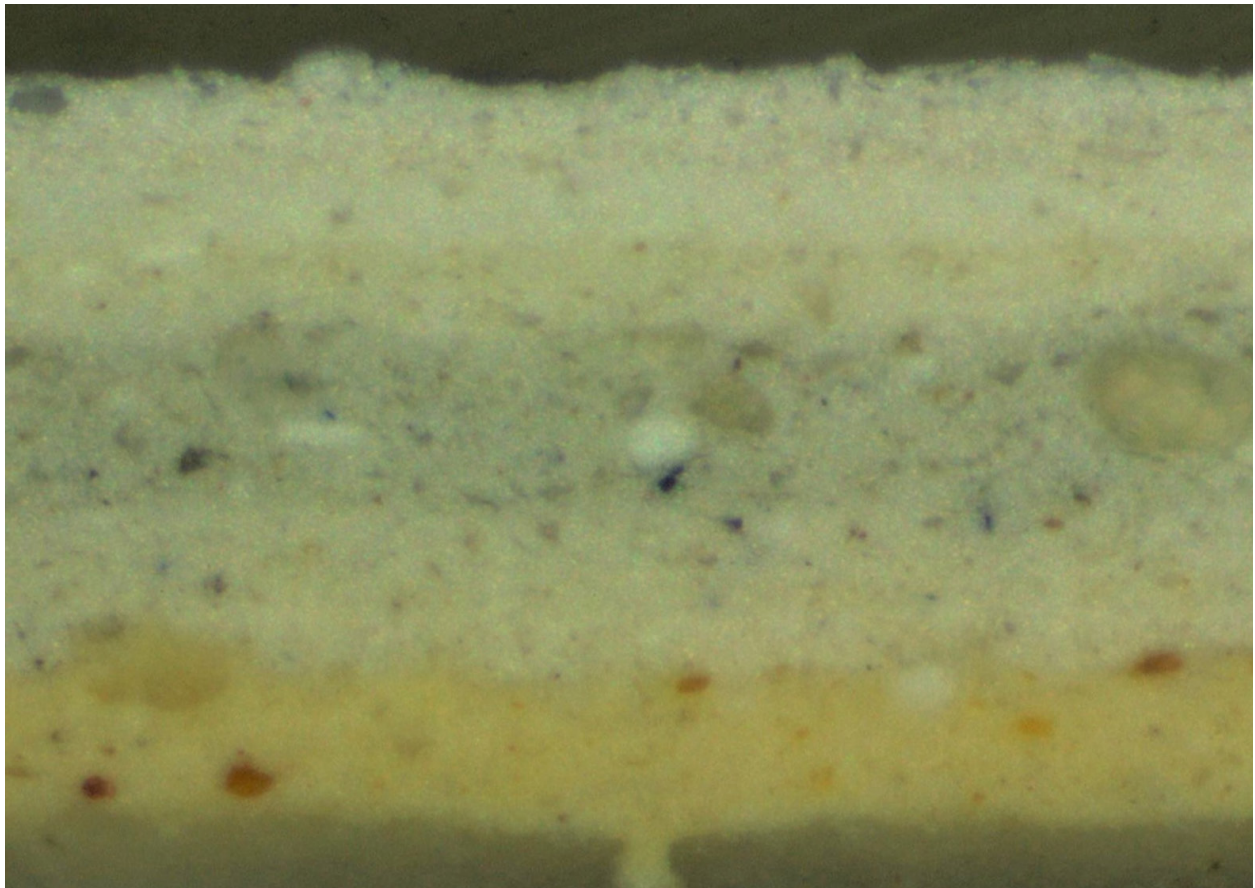
Sample twenty-six was taken from the gold beading in the balcony directly below the organ. The wood substrate has been heavily abraded, suggesting that it may have been sanded. The dark substance to the left above the substrate may be an early faux grain-ing or gilding campaign, but there is not enough evidence to tell. The beading appears to have been painted white and then varnished. Then it may have been gilded in bronze or painted golden brown. Most recently, the beading has been gilded.

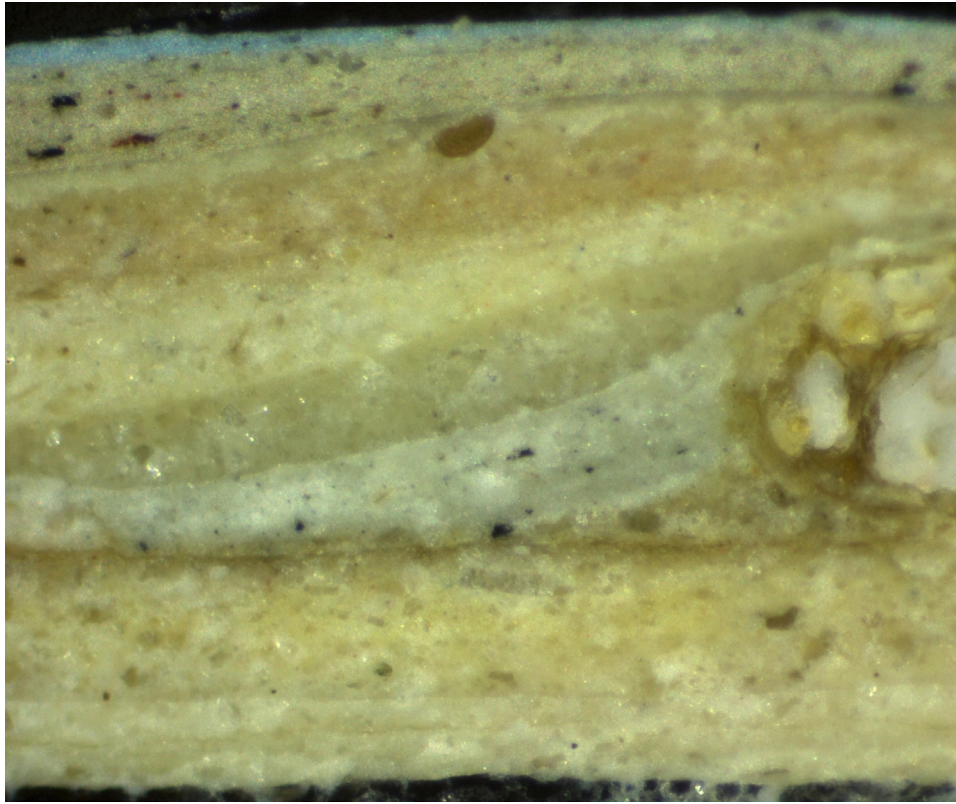
Sample twenty-four was taken from the right wall inside the alcove to the right of the alter. The sample was taken down to the plaster substrate, although the substrate separated from the sample. The alcove walls appear to have been originally painted a bright yellow when they were first added. The walls were subsequently painted different shades of cream and beige.

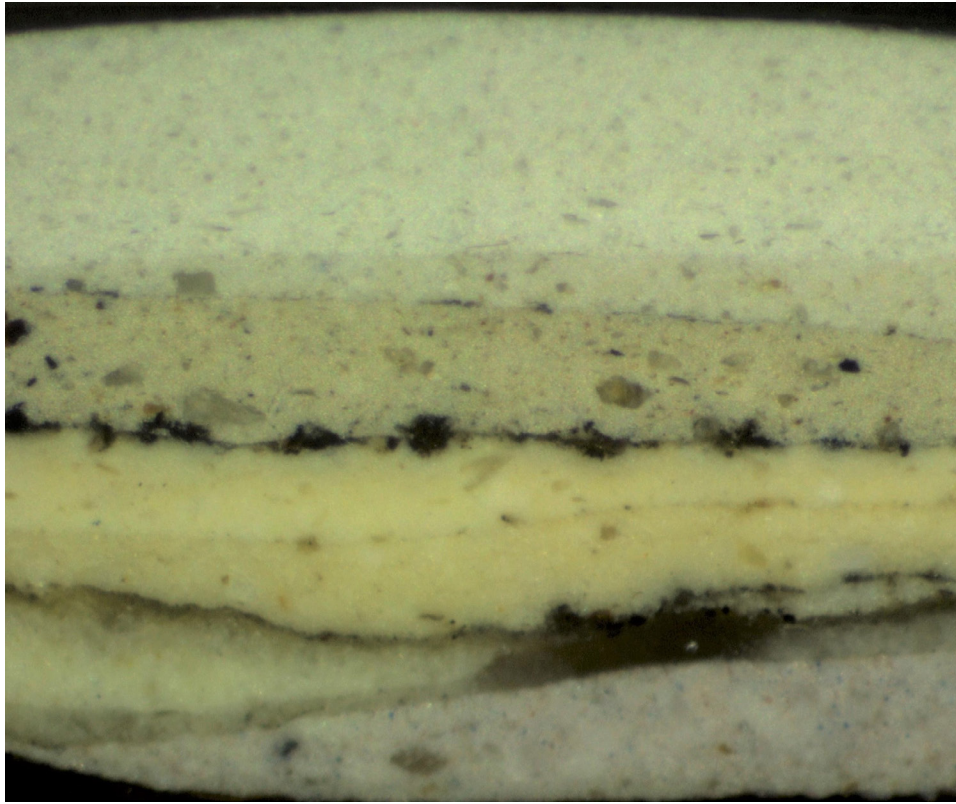
Sample twenty-eight was taken from an inset blue panel in the balcony in the choir loft to the right of the organ. The wood substrate is missing, but the earliest color appears to be a cream. The golden brown color may have been a later faux graining campaign that may have been sanded or otherwise disturbed as indicated by the large swirl to the right. The inset panel was later painted several shades of creams, yellows, and beiges before finally being painted blue. Based on this sample, the blue does not appear to have historic precedent.

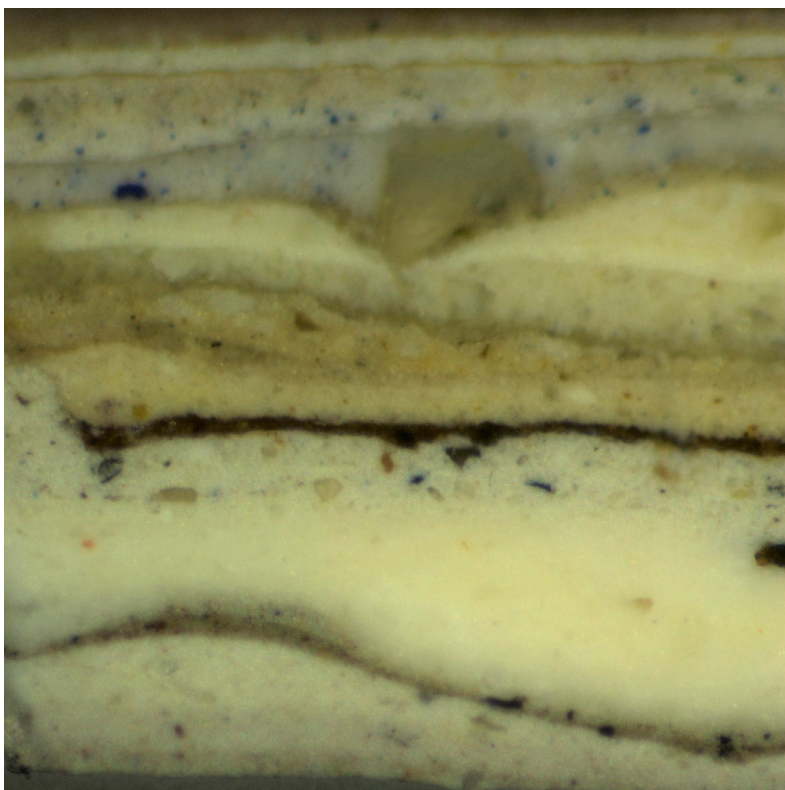
Sample twenty-nine was taken from a raised panel in the balcony in the choir loft to the right of the organ. The wood substrate is missing, but the earliest color appears to be a cream. The panel appears to have been painted different shades of creams, yellows, and beiges. There are also what appear to be several heavy dirt lines.
