JOSEPH MANIGAULT HOUSE MASTER BEDCHAMBER PAINT REVEAL STUDY

APRIL 22, 2017

Prepared for the Charleston Museum and the
Conservation (HP 810) Course at the Clemson
University and College of Charleston Graduate
Program in Historic Preservation

By Mary C. Fesak

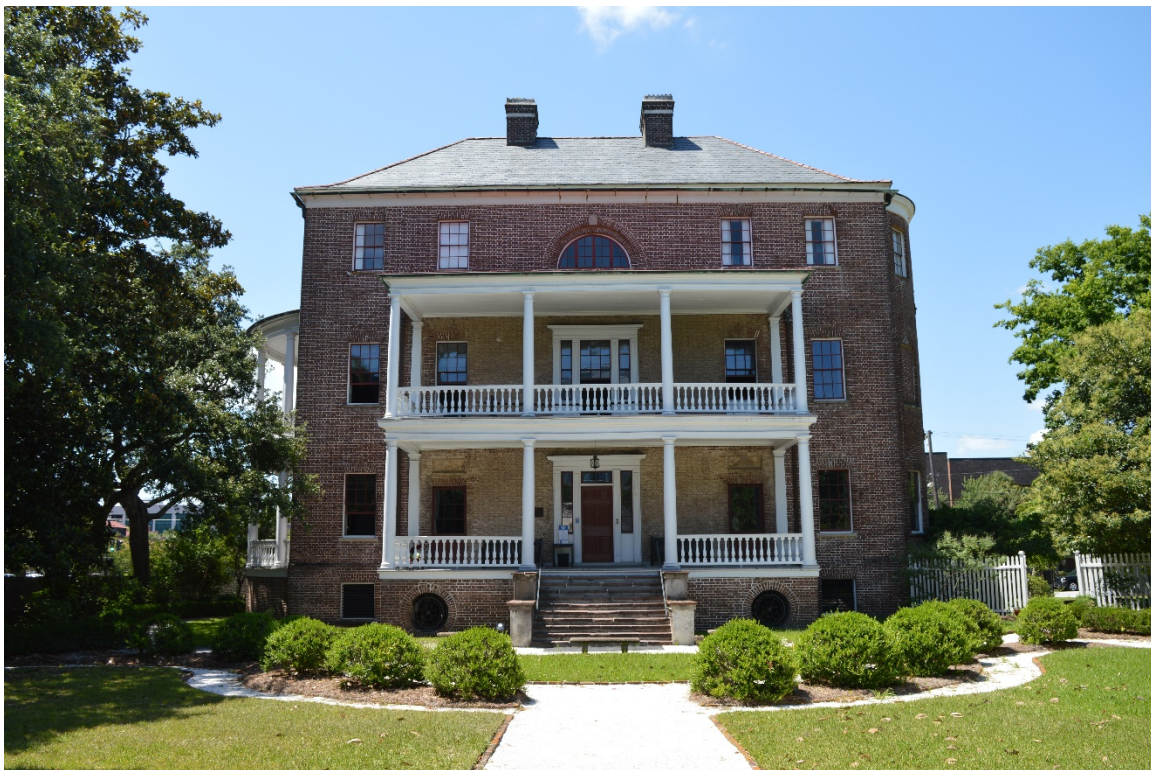
The Joseph Manigault House is a four-story, center hall, double pile building constructed in the Adam, or Federal, style. It is built entirely in Flemish bond brick. The south side features a two-story, four-columned piazza, while the north side has a plain entrance at the second floor. The east and north elevations have semi-circular projections, while the west elevation has a two-story semi-circular piazza. The windows are six-over-six sliding sash except for the third-floor fanlight above the south piazza and the Palladian window in the north stair hall. There are also blind windows on the north elevation to mask the service staircase and dressing room. The door on the north elevation is also Palladian. The doors on the south elevation are six-paneled with sidelights. The building has a hipped roof clad in slate with two interior chimneys flanking the central hall. The roofs above the curved projections are conical.

Figure 1 The south elevation of the Joseph Manigault House.

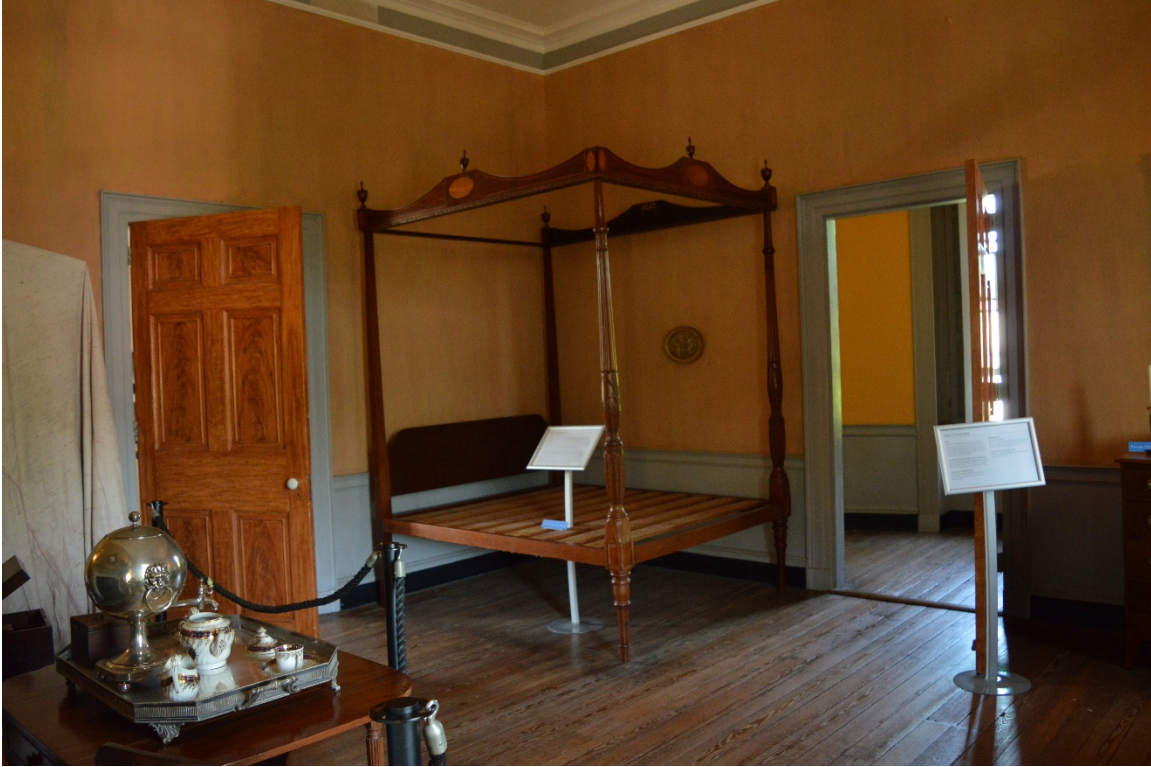
Figure 2 The master bedchamber with the current orange paint.

The walls of the bedchamber are currently painted orange with flecks of brown splattered on. There is no historical precedent or physical evidence for this paint color and technique. There are approximately fourteen layers of paint on the wall, with a skim coat of gypsum plaster over the fourth generation of paint. After the original layer of paint, the wall was painted varying shades of blue-green three times.

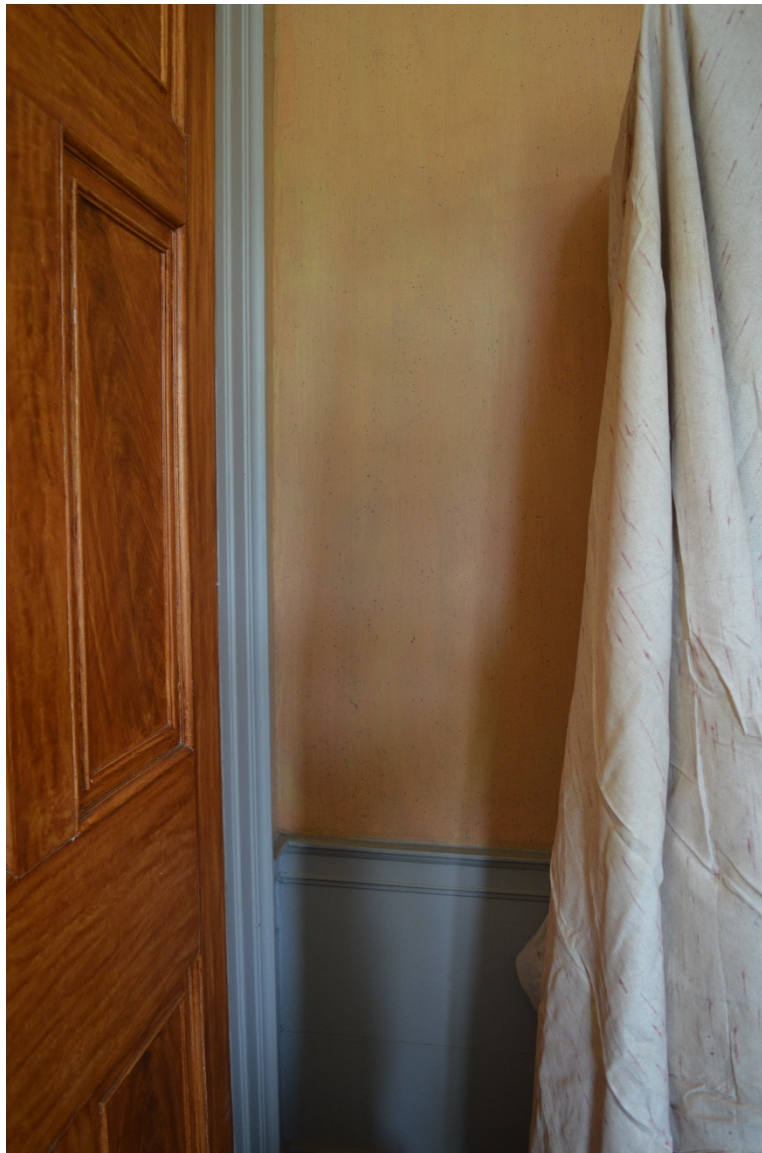
The northwest corner of the master bedchamber was selected for the reveal because it did not obstruct tours. The reveal was created in the corner directly above the chair rail in an effort to locate a decorative border pattern. The reveal measured approximately one foot by one foot four-and-a-half inches upon its completion.

Figure 3 The location of the reveal.

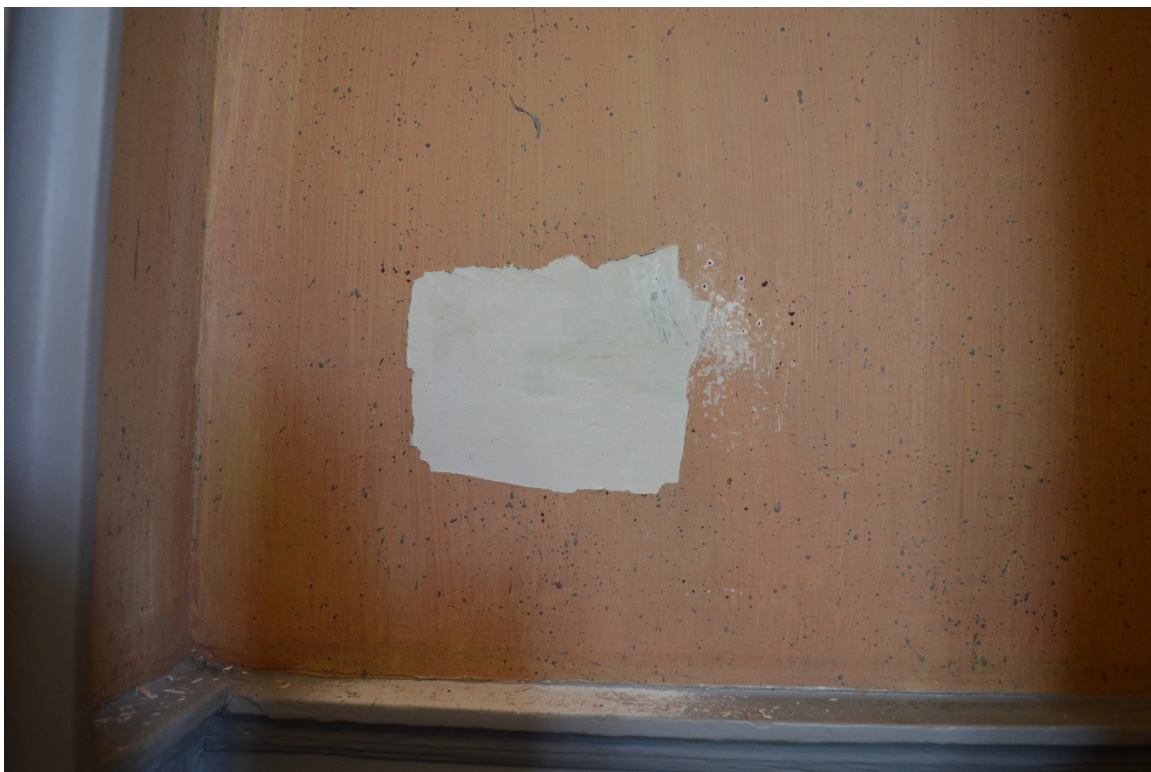
best practices for creating reveals as discussed in the literature review. The overpaint removal was first completed using a No.1 X-Acto knife with a No. 11 blade following Buck's recommendations for the careful manual paint removal. Initial probes found that a skim coat of hard gypsum plaster had been applied to the wall during the late-nineteenth or early-twentieth centuries, encapsulating the earliest paint layers. The plaster and its overpaint were removed using a sharp one inch chisel. Afterwards, a small two-inch square section of the original wall paint was revealed using the X-Acto knife.

Figure 4 The gypsum plaster skim coat.

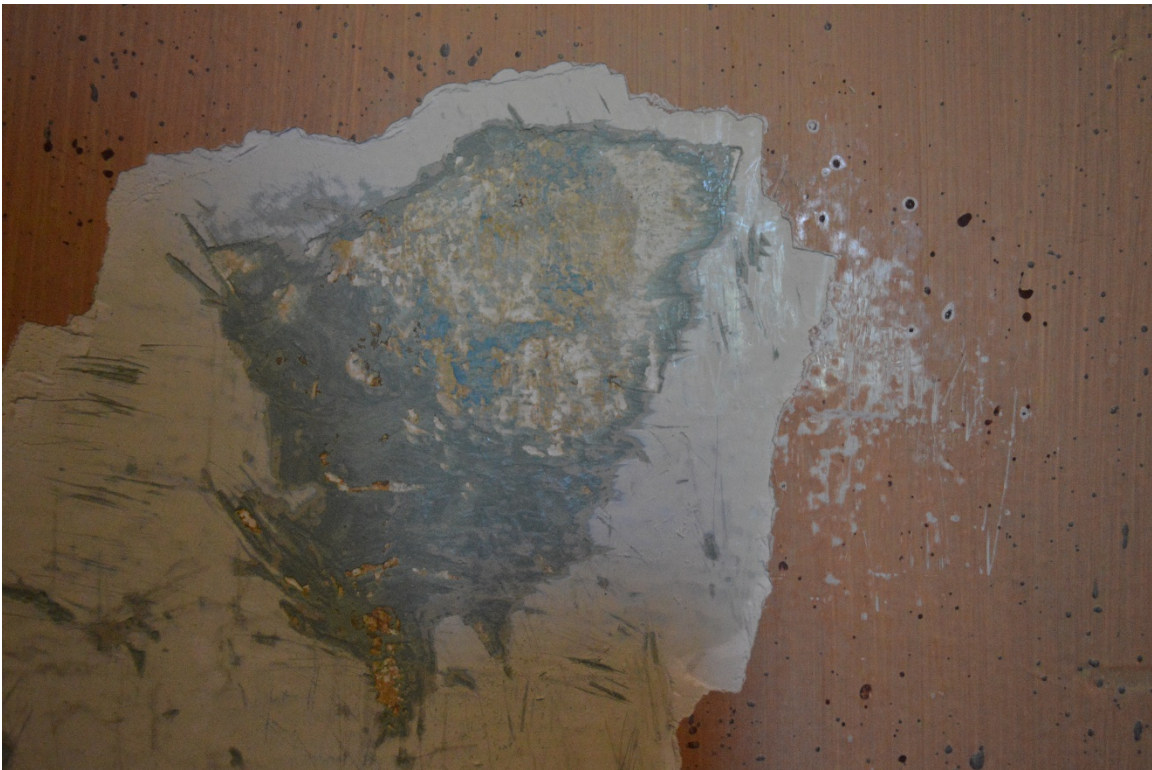
The manual overpaint removal proved to be problematic because the brittle decorative paint patterns were more tightly bonded to the overpaint than to the original ground paint they had been applied to, causing them to be scraped off with the overpaint. Several chemical paint strippers were tested to try to remove the overpaint without disturbing the decorative paint scheme. The tests were conducted over one-inch square areas using a cotton swab to carefully

Figure 5 The reveal during the manual scraping process.

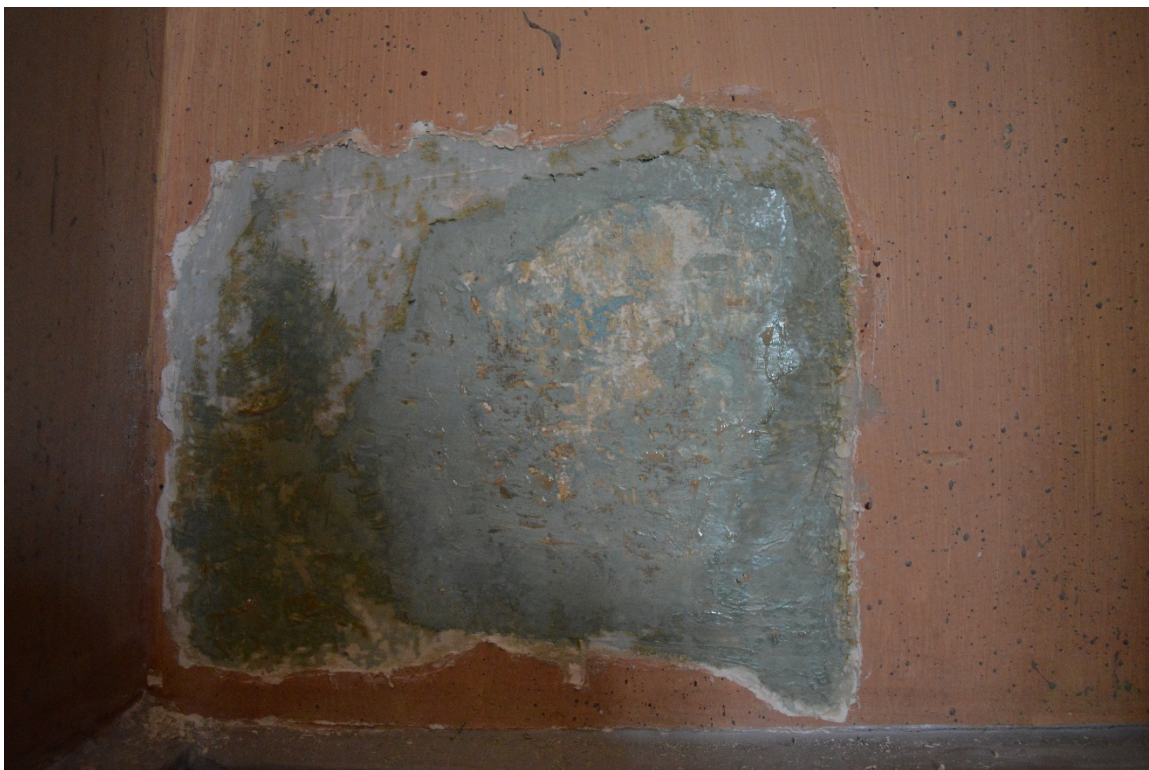
apply the strippers. Mineral spirits did not successfully remove the overpaint, while denatured alcohol also removed the water-soluble original distemper paints despite its careful application. CitruStrip proved to be the most successful because it softened the overpaint enough for its removal, but its gel-like texture did not cause the original paints to run or be removed with the overpaint. However, some of the green overpaint remained in places where the stripper did not penetrate for a long enough period of time, but it was feared that another application might soften the original paint. The CitruStrip was applied over the entire section of wall using an artist's paintbrush for greater control.

Figure 6 CitruStrip applied to the overpaint.

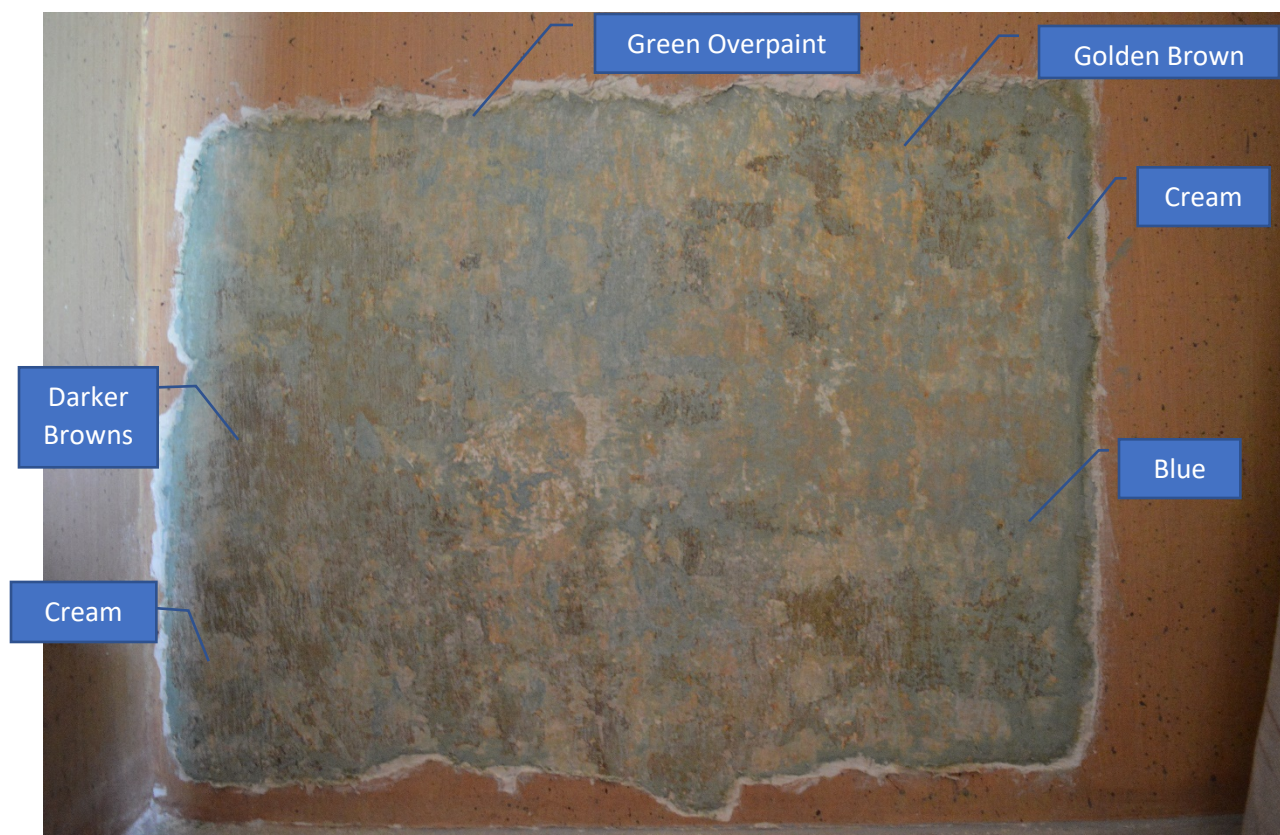
The paint study found that the ground paint was a light golden brown. There was a decorative paint pattern above the chair rail and running vertically in the corners in a darker reddish brown. There are also cream areas, as well as a blue glaze. While some of the forms painted in the reddish brown appear to be geometric, the overall design appears to be organic with no discernable pattern. Because of the apparent lack of an overall pattern and the variety of shades of gold, reddish brown, and cream, it is also possible that the wall was marbled with a decorative blue glaze pattern.

Figure 7 The completed paint exposure. Note the different shades of golden brown, darker brown, and cream.

Several factors should be considered in the interpretation of the results. The exposed paint colors may not be completely accurate as they were exposed to paint stripper and light. It was also difficult to remove all the green overpaint. The natural aging of the pigments should also be taken into consideration. Upon close visual inspection, the colors did not appear to change when they were exposed by stripper as opposed to manual scraping. It may be best to determine the original colors using a cross section, although the colors may also not be accurate in photomicrographs. The analysis of the paints' chemical components through spectroscopy at a laboratory, such as the Warren Lasch Conservation Center, may also help in determining the original color and paint composition. In addition, some colors or parts of the design may have been accidentally removed by the stripper or when the wall surface was prepared for subsequent paint campaigns. Visually, the CitruStrip did not appear to remove either the reddish brown or

The Charleston Museum has two main options in continuing the paint analysis and restoration of the bedchamber. The museum could opt to move forward and paint the entire bedchamber the golden-brown ground color. The other option is undertaking additional paint research since the decorative pattern has still not been determined. An even larger reveal should be created in the current location, as well as possibly below the cornice, around the chimney, and near the windows to better understand the paint scheme. Creating reveals is inherently destructive, a factor that should be weighed since it could impede future research. If a larger paint study is undertaken, an even broader range of chemical strippers should be tested to see if there is one that does a better job of removing the green overpaint without disturbing the decorative paints.

Should it choose to, the results enable the Charleston Museum to paint the room in the historically-accurate golden ground color, although it should be done with the understanding that the gold varied in shade and a more accurate color match would most likely come from paint that has not been exposed to a chemical stripper. To undertake a more accurate but expensive restoration, additional reveals need to be created to gain a better understanding of the decorative paint scheme so it can be recreated over the golden ground paint.

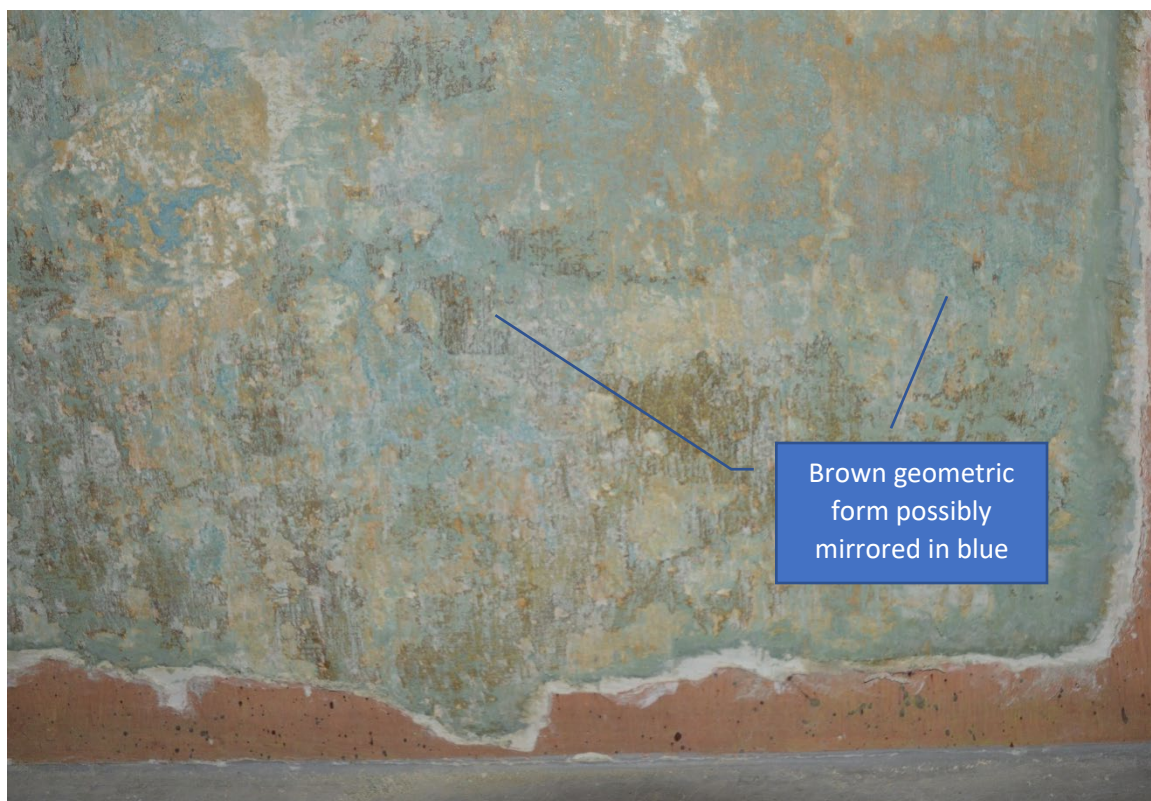
Figure 8 Possible border pattern in brown and blue.
