St. Mary's Interior Paint Report

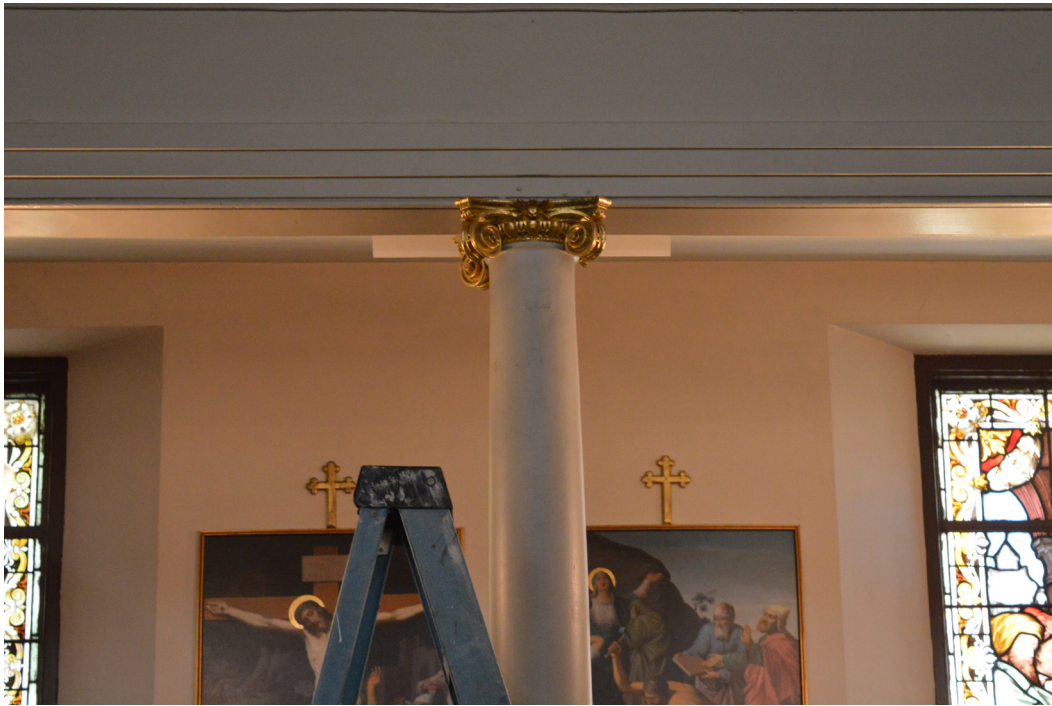
METHODOLOGY CHART			
PAINT SAMPLE NUMBER	LOCATION	SAMPLING METHOD	DESCRIPTION
SMI_1F	Top of the second column from the front on the right	Sample cut with #15 scalpel and extracted with tweezers	Small triangular sample, some substrate
SMI2	Capital of the same column, taken just above the right volute	Sample cut with #15 scalpel and extracted with tweezers	Very small sample, some substrate

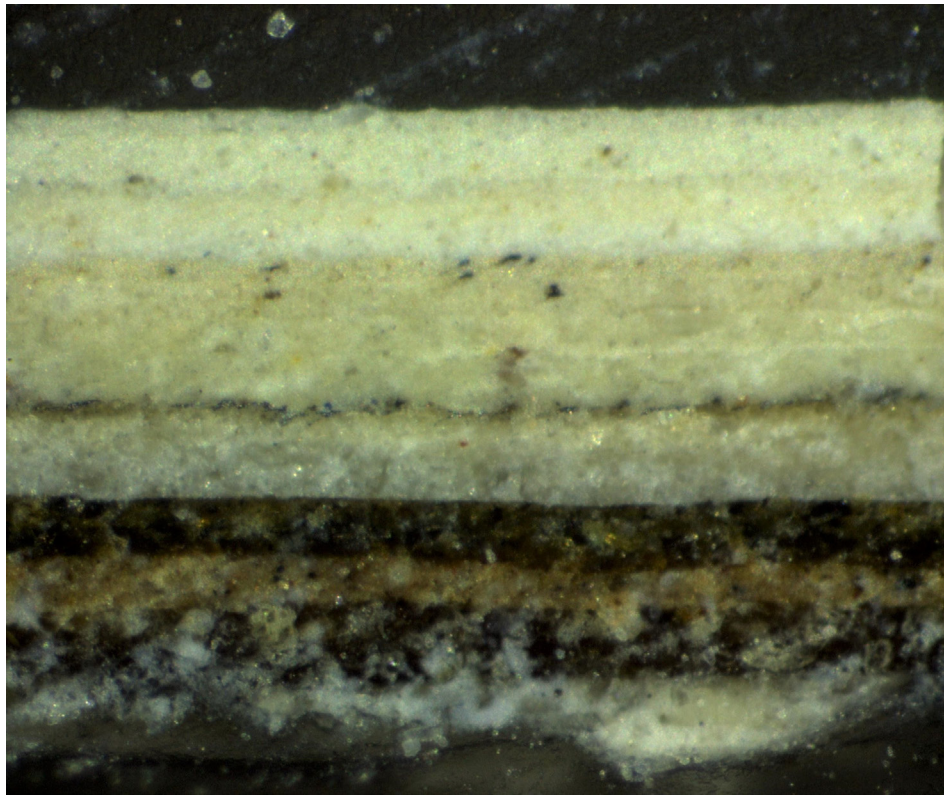
PAINT STRATIGRAPHY FORM SAMPLE NUMBER : SMI_1F	
LAYER DESCRIPTION (STARTING FROM SUBSTRATE)	COLOR NAME
1. Substrate - wood	
2. Smooth - paint	Golden Brown, brown inclusions
3. + Smooth - paint	Dark Brown, gold inclusions
4. / Smooth - varnish	Clear, brown dirt layer
5. ++ Rough - paint	Beige, small brown inclusions
6. - Smooth - paint	White
7. - Smooth - paint	Beige
8. + Smooth - paint	Cream, very fine inclusions

Sample one was taken from the top of the column shaft. There are approximately seven layers of paint with a wood substrate. The substrate is abraided and filled with a white substance, indicating that the column may have been sanded. The earliest campaign appears to have been a faux wood grain with a light grain color, dark graining color and a clear coat of varnish. The column was painted different shades of beige, cream, and white in more recent years.

Additional paint samples should be taken from areas of woodwork that would have been difficult for workers to sand to see if the earliest paint layers can be determined. Exposures should be made on the column shafts to see if there is evidence of faux wood graining. Exposures should also be made on the column capitals and gold beading to see if evidence of early gilding can be found. The walls and window alcoves should also have exposures made to reveal the original paint colors to enable color matches to be made to repaint the church. The paint analyst should make sure to investigate for multiple layers of plaster when making the exposures.
